The Stage Zero approach – lessons from North America on restoring river, wetland and floodplain habitats

Fiona Bowles, Stewart Clarke, Ben Eardley, Richard Jeffries and Peter Stone

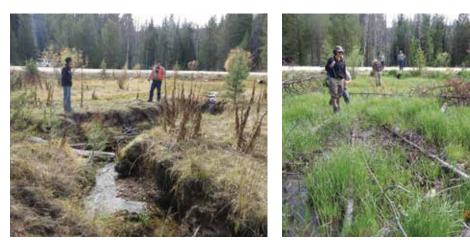
Pre-restoration channel (left) and post-restoration 'wet meadow' (right) at Dick Creek, Oregon. Paul Powers/US Forest Service

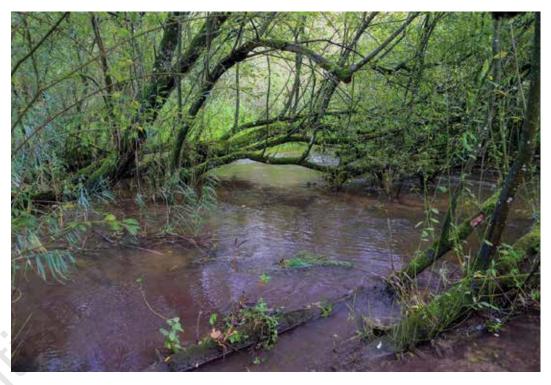
The River Nar in 2021, post Stage Zero. Charles Rangeley-Wilson

Norfolk Rivers Trust has implemented a full floodplain reconnection trial on the River Nar, a chalk stream that was modified historically by the construction of a raised leat (an artificial channel) for milling activity. Over the past few years a breach had opened in the leat, spilling an increasing proportion of its flow across the floodplain below. The water passes through a former poplar plantation, turned willow carr, and eventually gathers in what is likely to be the original, natural pathway of the river. The leat bed was above the valley bottom, so in 2019 a new small channel was excavated in order to 'step' the river down across the floodplain. The relatively steep gradient of the floodplain and existing woodland habitat allowed the stream to evolve rapidly. By summer 2020, Norfolk Rivers

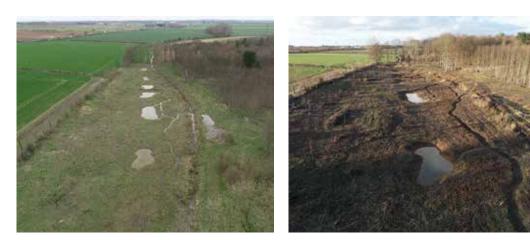
Nettleham Beck demonstration site, where a network of slightly sinuous channels and ponds were excavated to reconnect stream and floodplain. When water levels are higher wood jams in the main straightened channel force water to flow out over the floodplain (left), while the channels remain dry during periods of low flow (right). Luca Mao/University of Lincoln

In 2017, in a project run by the University of Lincoln and the Environment Agency, a 2ha multi-channel wetland system was created along a 250m stretch of a small, groundwater-fed limestone stream. The project's primary aim was to demonstrate to farmers and landowners the relatively manageable scale of the physical change required to reconnect river channel to floodplain. The works took place on the University of Lincoln's Riseholme campus, which conducts agricultural research and training. The channel had been straightened historically, and so restoration involved creating a network of sinuous interconnected channels and ponds, as well as partly blocking the main channel with woody debris, including live willow that would establish and provide protection against bank erosion. The University of Lincoln is continuing to monitor changes in flow, water quality and macroinvertebrates, among other factors. Postcompletion surveys reveal that the project has successfully created habitats that remain wetter for longer during times of low flow, which will increase resilience to periods of extended dry weather.

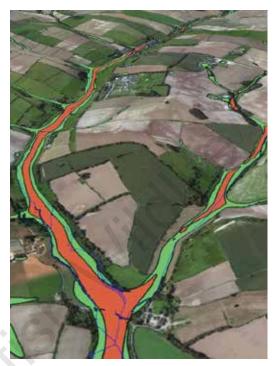
The valley bottom floor and the present floodplain (zone 3) of the River Piddle, mapped using LIDAR. Peter Stone

It soon became apparent that the current image of a floodplain, which periodically floods from the river channel, does not reflect the true extent of the area that should be considered for restoration. For the River Piddle, for example, mapping identified that the present floodplain represents about 48% of the original valley floor prior to its modification. Identifying suitable locations for restoration is challenging, especially where developments or transport infrastructure occupy parts of the valley floor, while complex patterns of land ownership
