## Chapter 14

# Design of an environmentally aligned flood alleviation scheme: the Burn of Mosset, Moray, Scotland

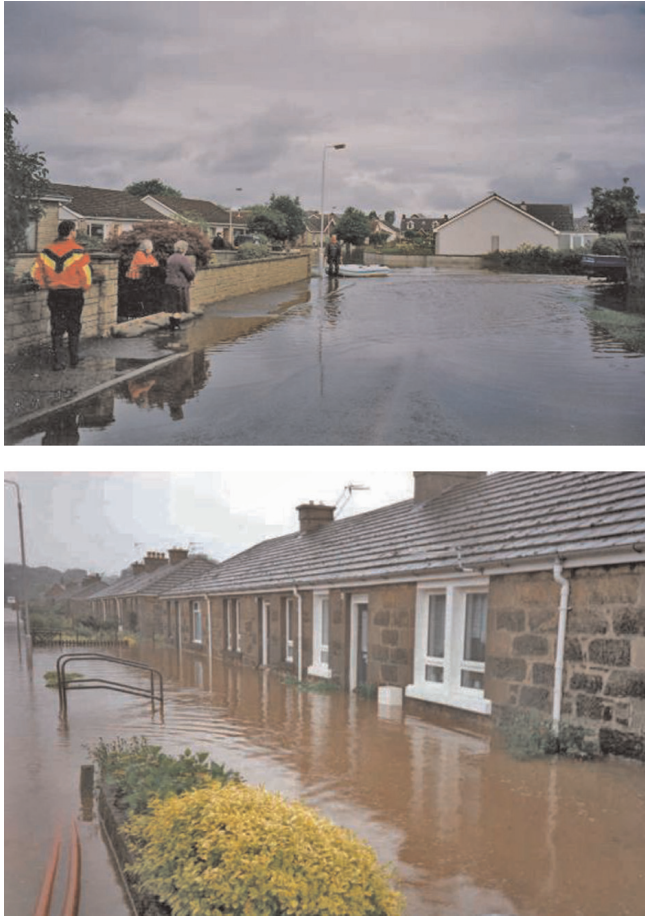
Figure 14.2 Flooding in Forres during the 1997 event

allowance for climate change up to 2080. Peak flow during the 1997 event was estimated at  $48 \text{ m}^3/\text{s}$ . During that event, approximately 430 homes and 27 commercial properties were inundated (Figure 14.2) and regional communications were seriously disrupted, with both the A96 trunk road and the Inverness to Aberdeen mainline railway being closed due to flooding.

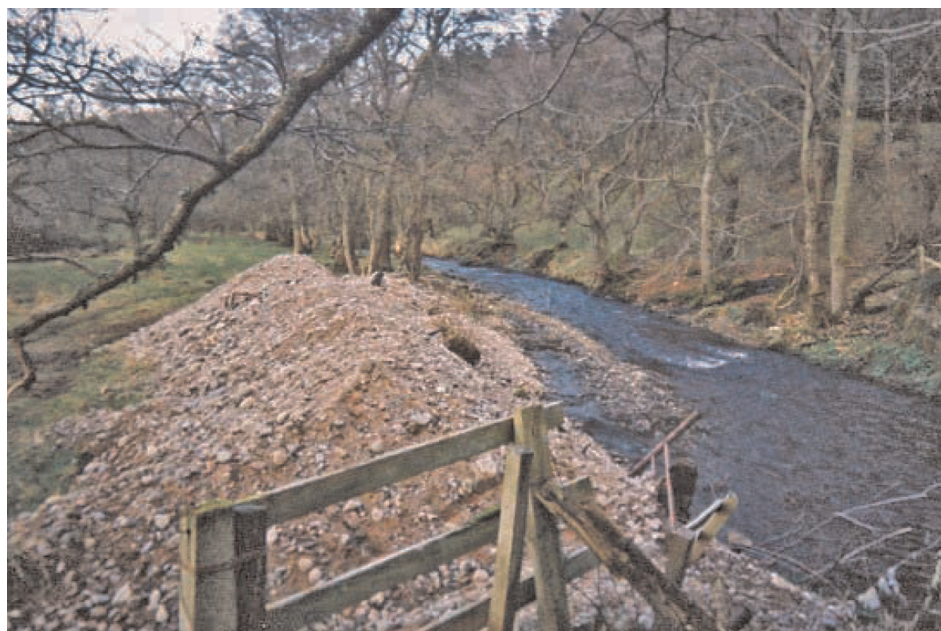
Figure 14.3 Gravel removal and *ad hoc* embanking of the channel of the Burn of Mosset upstream of Forres

However, geomorphological reconnaissance surveys (performed using methods described by Thorne *et al.* (2010)) performed as part of feasibility studies for a FAS revealed that the Burn of Mosset is highly active geomorphologically, and that it transports substantial quantities of sediment ranging in size from cobbles to sand and silt-sized material. Most of the cobble and gravel-sized bedload is deposited in the channel upstream of Forres, in the form of both shifting gravel bars and semi-stationary riffles, which have historically been managed for agricultural land drainage by dredging, with the dredge spoil used to build flood embankments on an *ad hoc* basis (Figure 14.3).

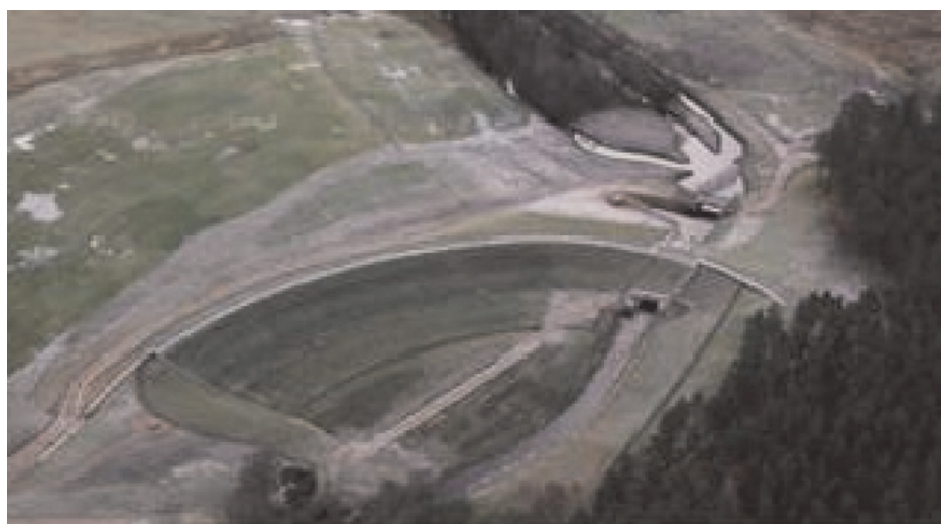
Figure 14.4 Chapelton dam

This appraisal resulted in option 3 (flood storage dam at Chapelton) emerging as the preferred option. The main structural element in this option is a dam at Chapelton (Figure 14.4), which restricts peak flows passing through it during flood events to a maximum of  $8.5 \text{ m}^3/\text{s}$ , with the excess flow being stored temporarily in a flood reservoir upstream of the dam, to provide a standard of service to Forres of at least 1% annual exceedance probability (i.e. the 1 in 100-year flood event).

One of the major concerns in designing the dam was to avoid the possibility of blockage of the flow control structure by sediments or floating material, such as large woody debris (LWD). The design selected for the flow control structure was novel, being a baffled crump weir. This is a passive flow control system (i.e. it has no moving parts and, therefore, meets the criteria for low operation and maintenance requirements) that had not been used in a dam of this size before.

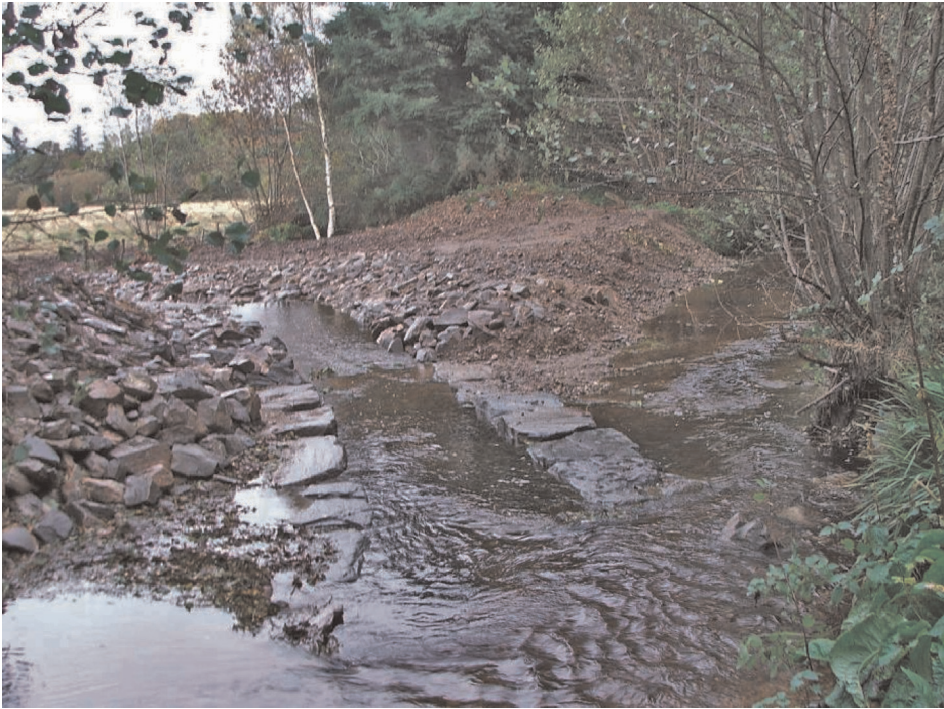
**Figure 14.6** Engineered breach as constructed in November 2008 to divide flow between the new channel (left) and the existing Burn (right). Note the block stone and riprap scour protection

When the left embankments of the Burn were artificially breached in November 2008, flow was divided between the pre-FAS, artificial course of the Burn of Mosset and the pilot channel cut through the Burn Management Works. Initially, the upstream breach did in fact divert 10–20% of the base flow, as planned. It was anticipated that the Burn Management Works would prompt recovery of a more natural form to the watercourse relatively slowly, with the new course taking perhaps 3–5 years to develop a multi-channel, anastomosed morphology that would convey the majority of flow formerly in the artificial channel. This was intended to allow time for the fluvial corridor to adjust progressively, thus avoiding a dramatic change in the geomorphology and ecology, which might lead to even a temporary loss of biodiversity.

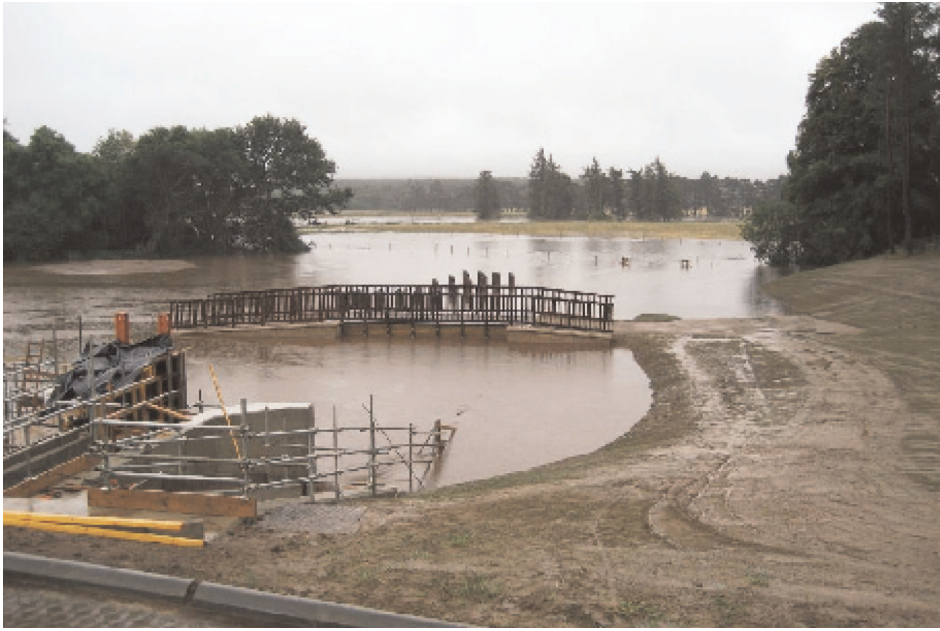
**Figure 14.7** First impoundment by the Chapelton Dam on 4 September 2009 – less than a week after implementation of the FAS

The dam and associated FAS were officially opened on 28 August 2009, albeit that construction had not quite been completed at that time. The dam impounded flood water for the first time just a few days later, on 4 September 2009, and the FAS functioned well during what was estimated to be a 1 in 20-year flood event (Figure 14.7). The ‘instantaneous’ peak discharge entering the storage area was estimated to be around 36 m<sup>3</sup>/s. Based on existing flood magnitude versus damage curves, implementation of the FAS avoided approximately £9 million of flood damages to the town of Forres.

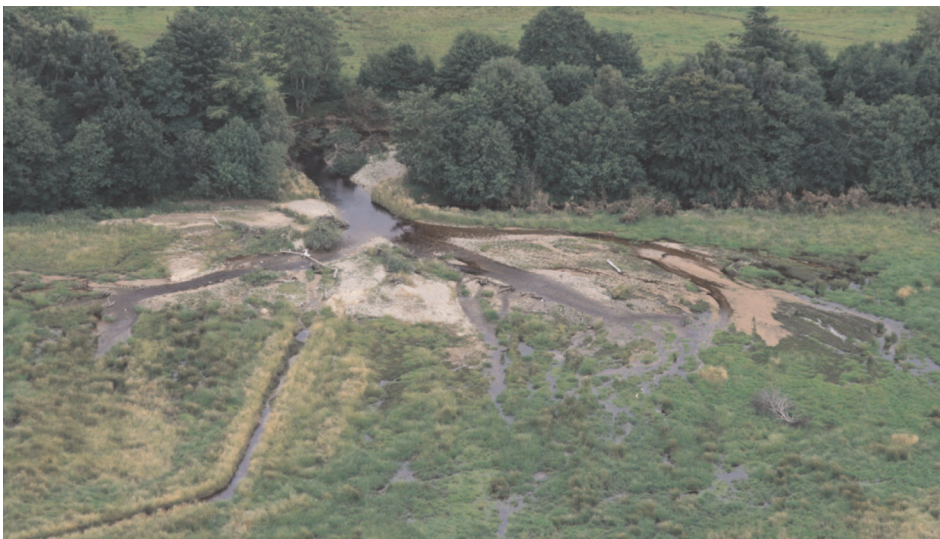
**Figure 14.8** Anabranching downstream of the upstream breach following the 4 September 2009 flood event. Note the development of anabranching upstream of the straight, pilot channel in the left foreground

The 4 September event supplied a considerable quantity of coarse sediment to the Burn Management Works, which was deposited as flow expanded across the flood plain. It also allowed floating debris to leave the artificial channel, and several pieces of LWD grounded in association with bars developing in the flood plain. Accretion of sediment and LWD triggered significant changes to the pilot channel, through the initiation of anabranching behaviour downstream of the first breach (Figure 14.8).

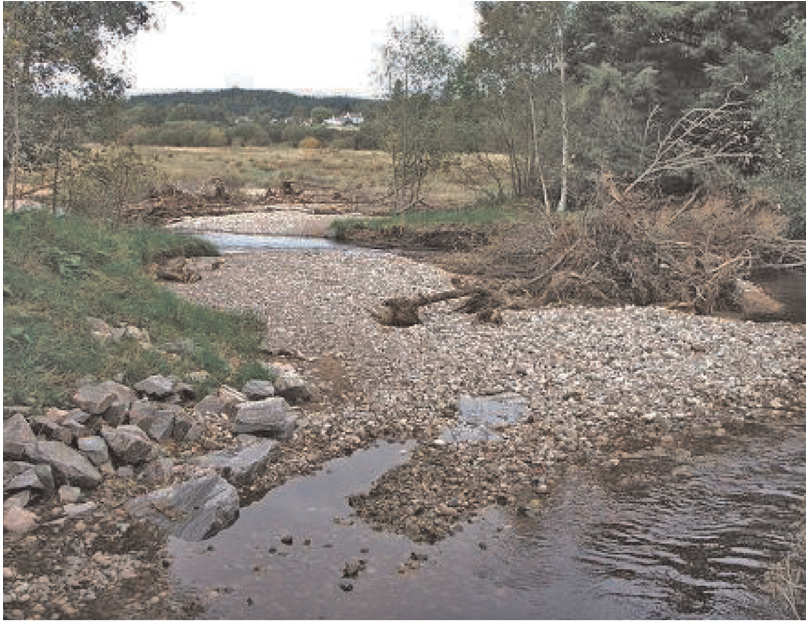
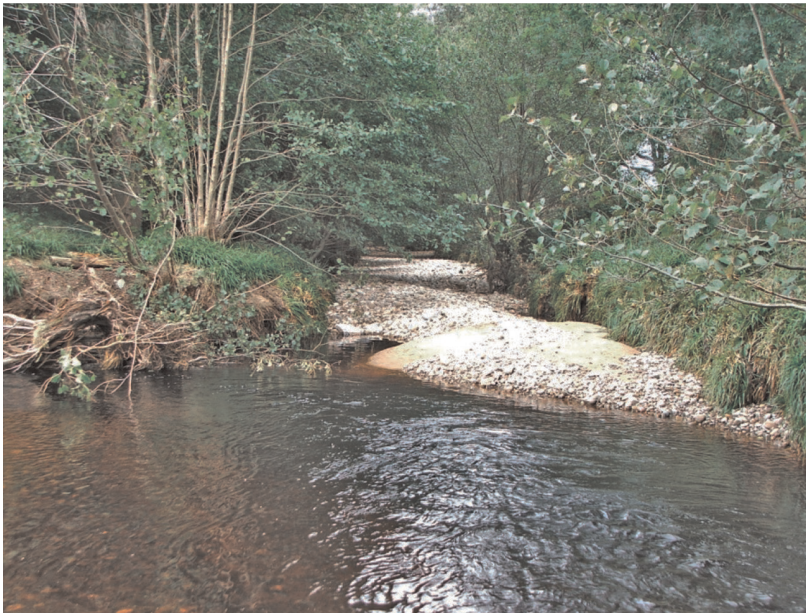
**Figure 14.9** (a) Controlled breach 1 in the left embankment following the 4 September 2009 flood. Note the disturbance to rock scour protection, widening of the breach, accretion of coarse sediment and accumulation of LWD. (b) The abandoned channel, viewed looking downstream of breach 1

The Burn Management Works performed as anticipated during the flood, although failure of rock and riprap protection and enlargement of the upstream breach during the event resulted in abandonment of the old course in favour of the new one more quickly than intended (Figure 14.9).

During the September 2009 flood, block stone and riprap scour protection installed at the upstream breach were unable to prevent bank erosion, with unintended consequences. This is similar to experience on the Jubilee River when it experienced a flood soon after construction, in January 2003 (Thamesweb, 2003). It is, therefore, recommended that additional attention should be paid to ensuring the stability of diversions or outlets in order to reduce the risk of their being damaged or bypassed, especially soon after construction and before the bank vegetation that provides natural erosion resistance has been able to recover from the disruption that is inevitable during project implementation.

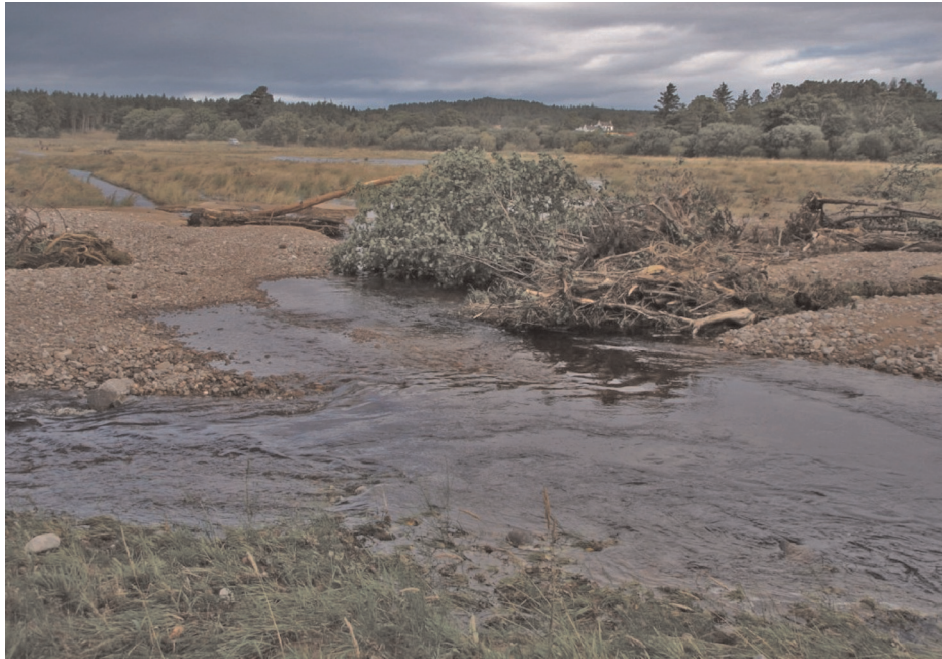
**Figure 14.10** Interaction between grounded LWD, fluvial processes and sediment dynamics in the Burn Management Works. Note the remnant of the pilot channel in the upper left of the photograph, the scour pool in the foreground, the anabranch on the left and the extensive coarse sediment deposition

approaching the control structure within the dam. LWD permanently grounded in the Burn Management Works is also interacting with fluvial processes and sediment dynamics to drive local scour, deposition, bar building, channel evolution and habitat diversification (Figure 14.10).

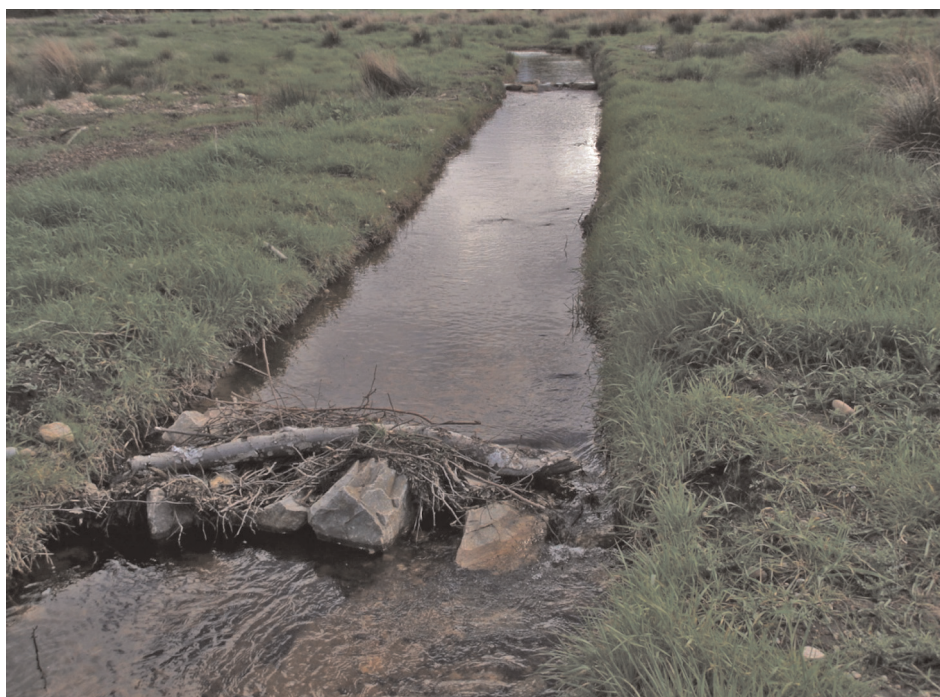
**Figure 14.11** Low boulder weirs constructed in the pilot channel and intended to encourage formation of a pool and riffle sequence. These have been successful in trapping LWD, but have not been effective in promoting pool and riffle formation

4. Finally, it is now realised that more attention should have been given to the design of microtopography and bedforms within the pilot channel. The design implemented included low, boulder weirs constructed at intervals along the pilot channel that were intended to encourage formation of a pool and riffle sequence (Figure 14.11).

Post-project monitoring shows these structures to have been ineffective and, with hindsight, it would have been preferable to vary the cross-sectional geometry and conveyance capacity along the pilot channel to create in-channel non-uniformity and facilitate exchange of momentum and sediment between the channel and its flood plain. This would have better coupled in-stream and flood-plain processes, encouraging localised scour and deposition and stimulating interactions between water, sediment and vegetation over a wider area.
