# Stage Zero?

## Exploring the potential of restoration to Stage Zero in UK agricultural landscapes

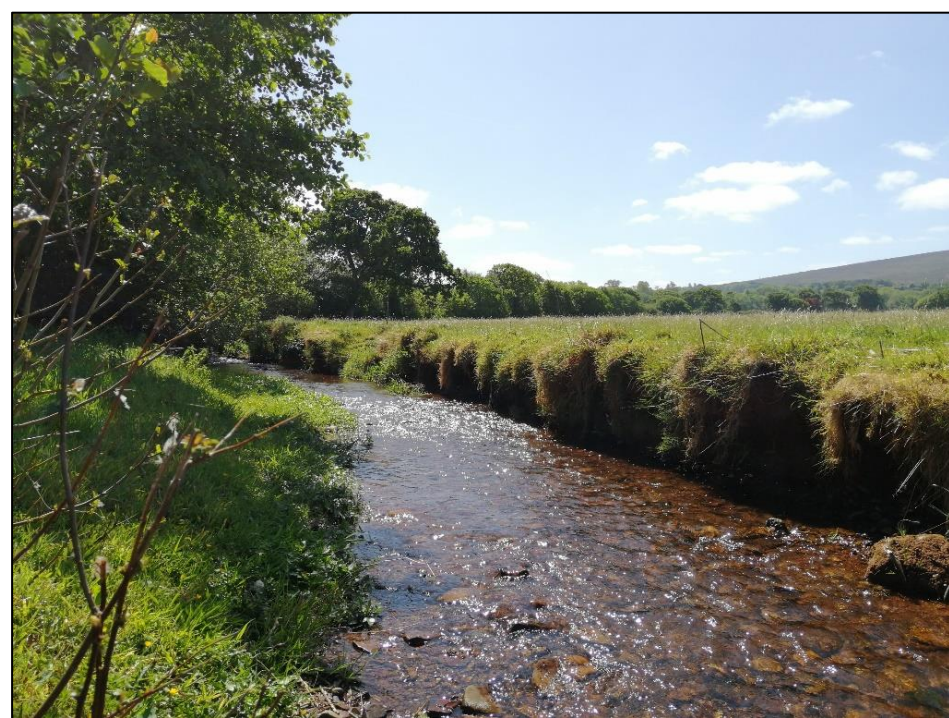
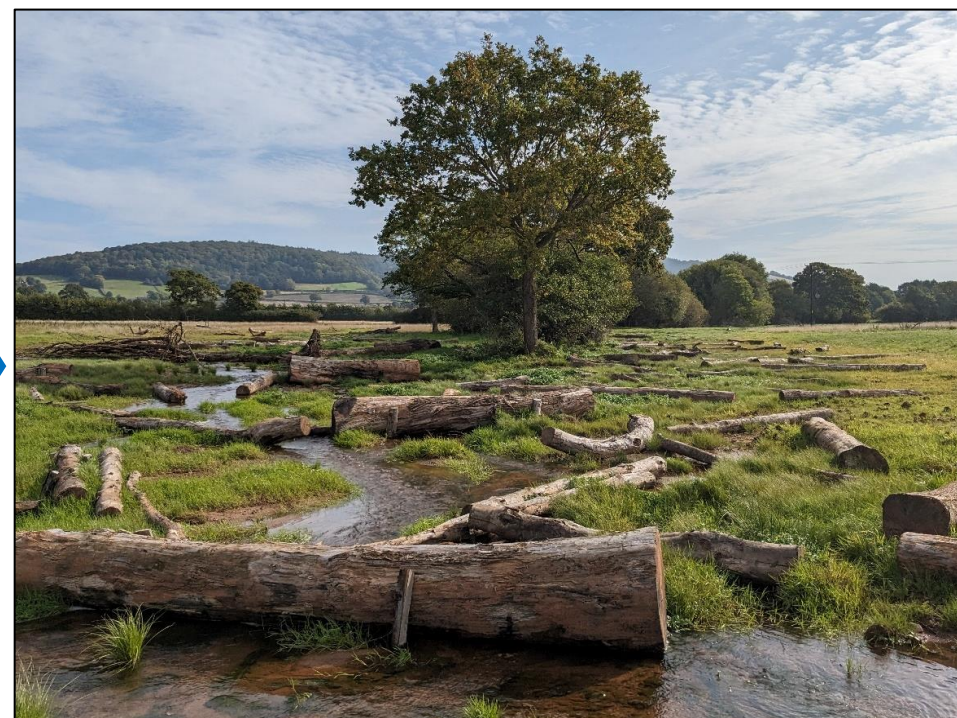
### The River Aller

Catchment size: 18 km<sup>2</sup>, width: 4 m (before restoration), slope: 1%, substrate: gravel  
The Aller, Somerset, was restored in 2022-3 by The National Trust. Restoration involved a complete valley-reset over 550 m.

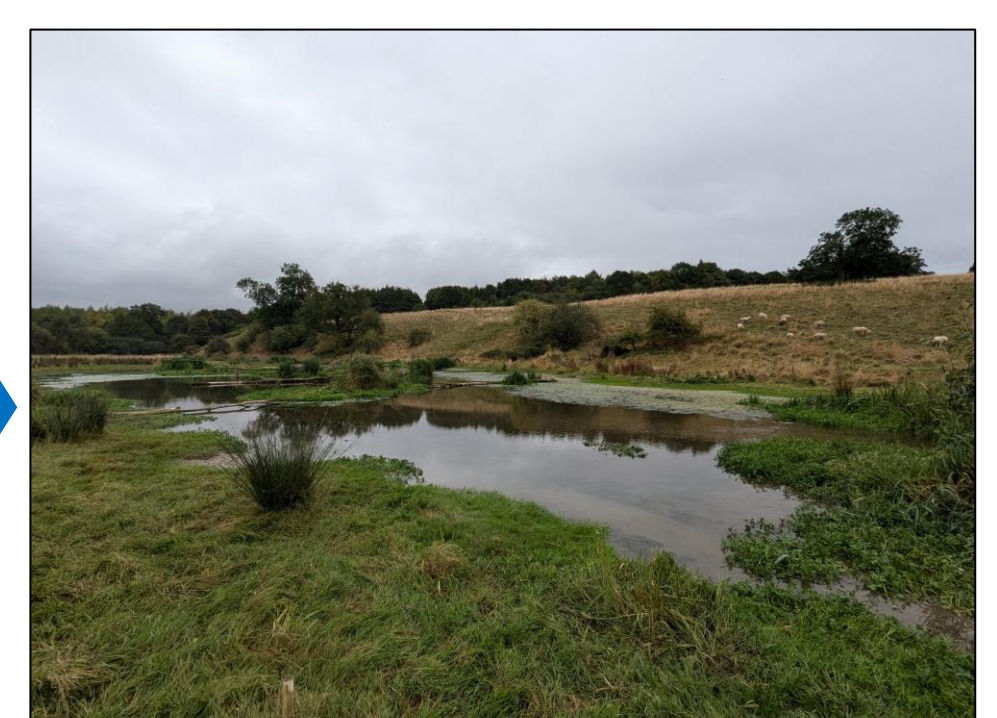
### The River Witham

Catchment size: 55 km<sup>2</sup>, width: 3 m (before restoration), slope: 0.2%, substrate: clay  
The Witham, Lincolnshire, was restored in 2022 by the Environment Agency, by infilling 200 m of channel and re-scaping the floodplain.
