# GEOMORPHIC EFFECTS OF RESTORATION TO STAGE 0 ALONG DEER CREEK THROUGH SUMMER 2021

March 17, 2022

Prepared for:  
**McKenzie Watershed Council**

Prepared by:  
Daniel N. Scott, PhD

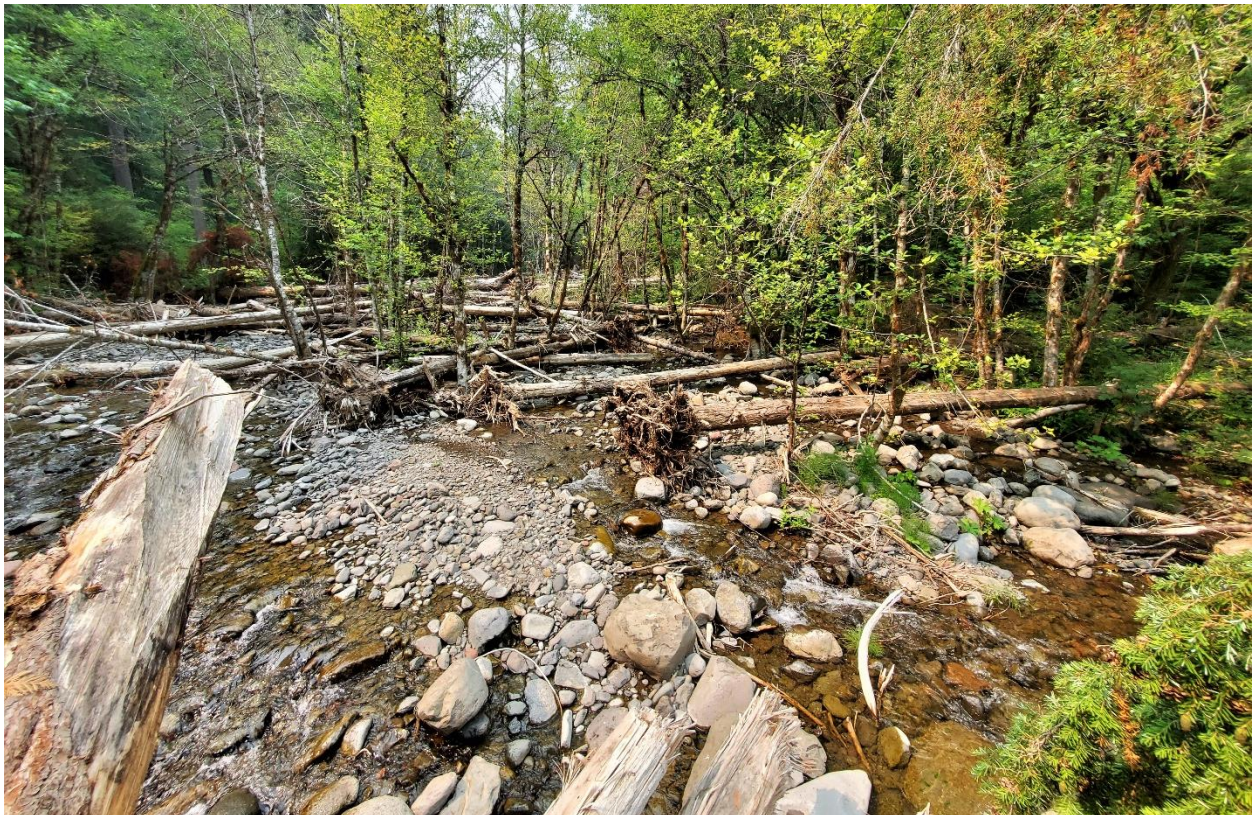
**Figure 5: Picture of a channel and floodplain in a recently restored portion of Deer Creek. Note that it is difficult to discern the boundary between the channel and floodplain.**

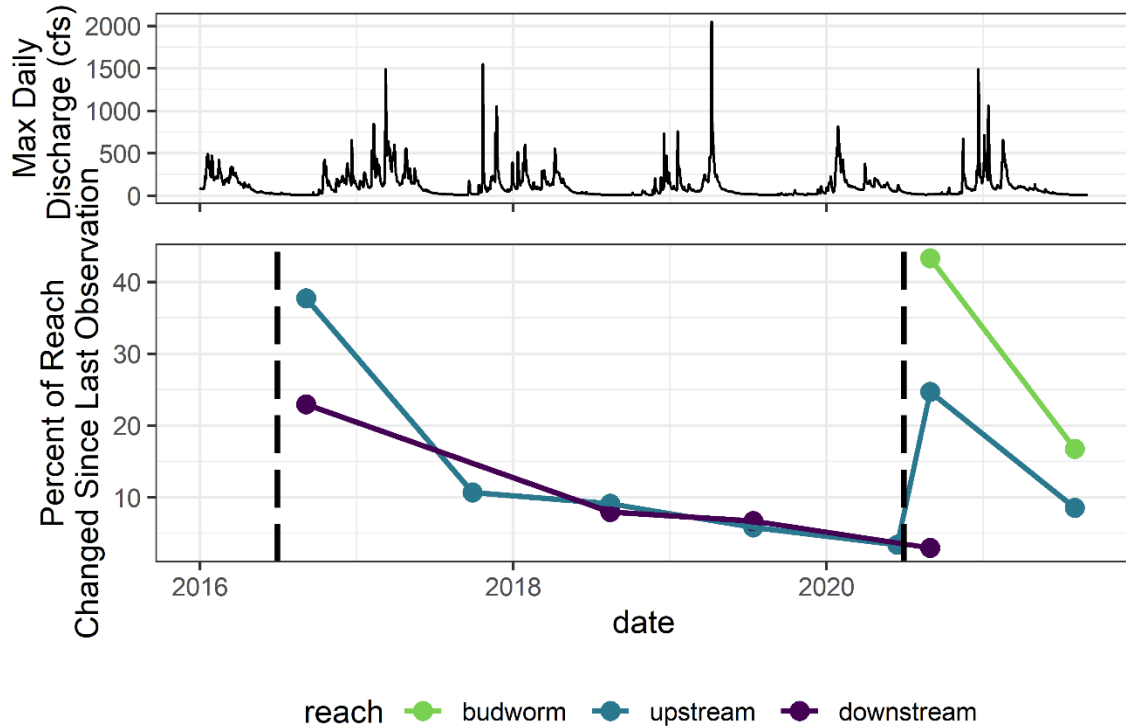
**Figure 8: Extent of change of geomorphic units since the preceding observation. Higher values indicate that a higher proportion of the valley bottom area changed from one geomorphic unit to another since the last observation. Dashed black lines show the timing of restoration phases 1 and 2.**

These moderate flows were generally insufficient to drastically alter the valley bottom. Change in geomorphic units was generally limited to 10% or less of the total valley bottom area from year to year and decreased slightly through time as the reach adjusted to its new topography and roughness (Figure 8). The dominant mode of change in the 4 years following phase 1 restoration was vegetation establishment in the active channel.

In the year following phase 2 restoration, peak flow at Lookout Creek only reached approximately 1,500 cfs, less than the approximately 2,000 cfs peak that occurred between phase 1 and phase 2 (Figure 7). While I lack direct measurements of flow on Deer Creek, based on timelapse imagery showing flow stage, flows in 2020/2021 were likely at least slightly lower in peak magnitude than flows from 2016 to 2020 (Figure 17). However, the geomorphic impact of this moderate flow was much greater than that of similar flows that occurred in the four years prior to phase 2 restoration, and it occurred over a large extent (16% and 9% of the valley bottom for the Budworm and upstream reaches, respectively; Figure 8).

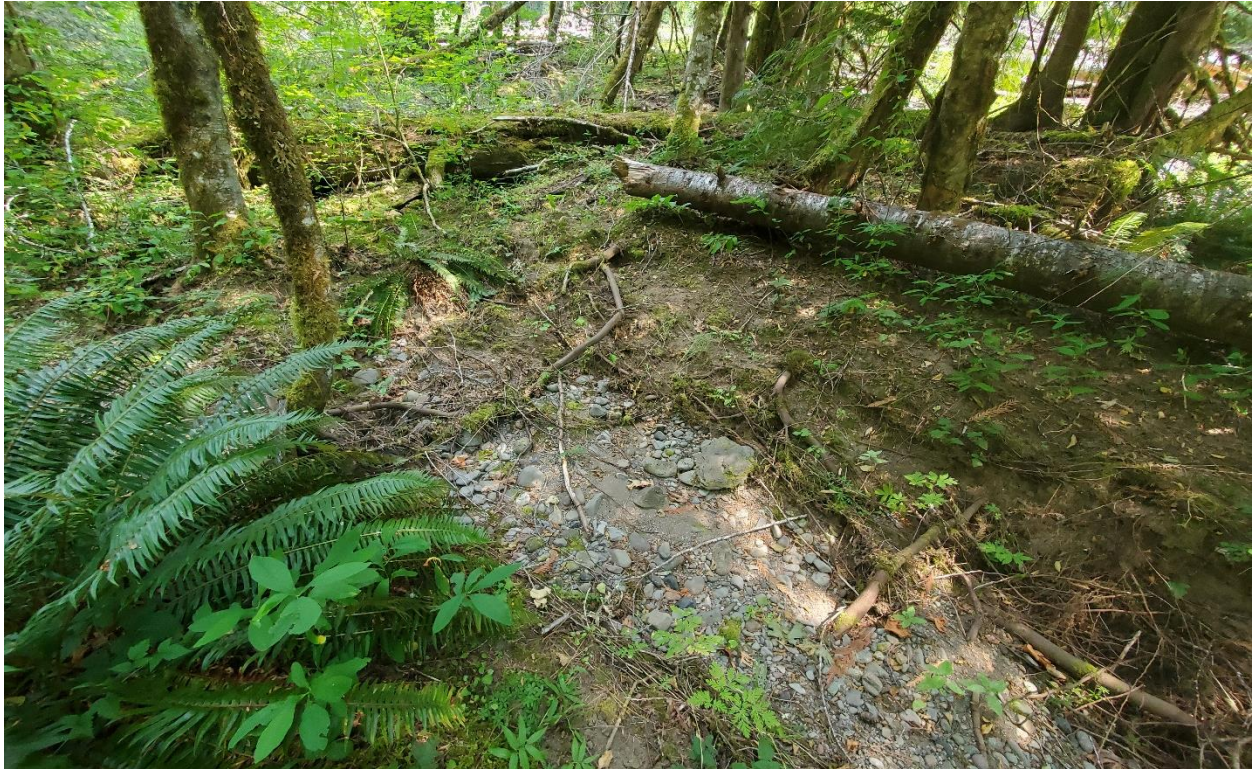
**Figure 10: Picture of a floodplain overbank channel in the upstream reach that was reactivated during a flood shortly after phase 2 restoration (August 2, 2021).**

The only exception to the general lack of geomorphic change across the valley bottom was the incision of multiple floodplain overbank channels (i.e., channels that activate during flows that inundate the floodplain, but do not fully connect to the low-flow channel network; Figure 10) during the 2018/2019 season, likely during the April 8, 2019 flood. Similar signs of floodplain overbank channel activation were not visible during other surveys.

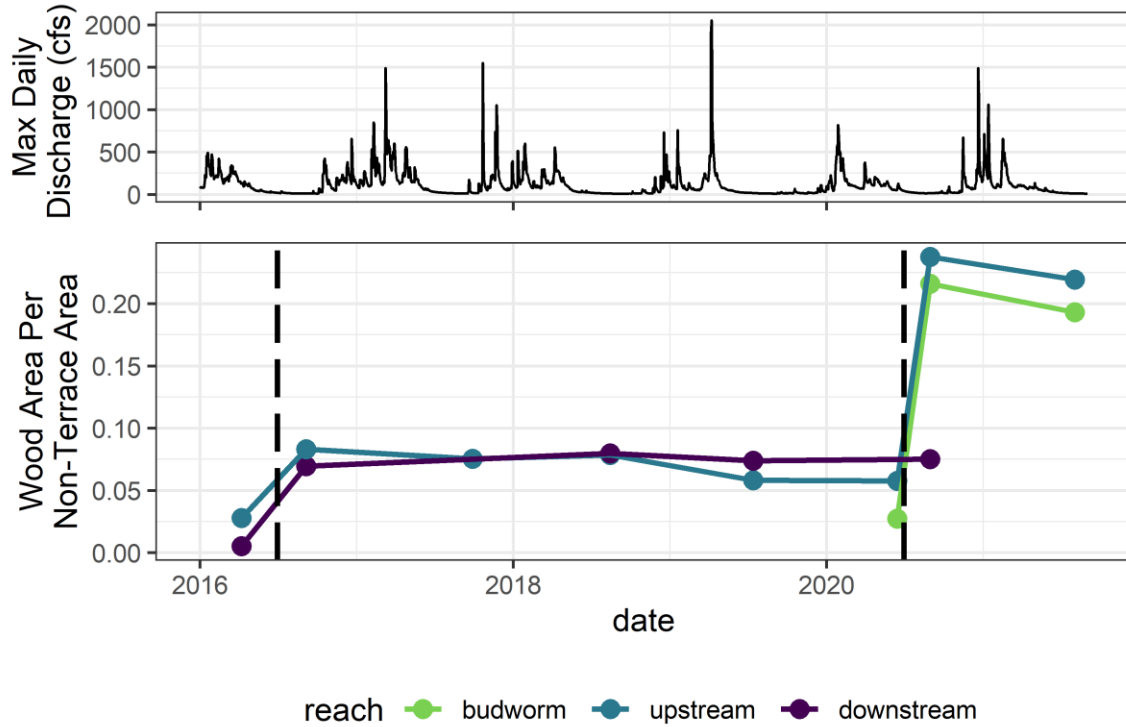
**Figure 13: Large wood load, as measured by the proportion of the non-terrace area of the valley bottom covered by wood, through time. Dashed black lines show the timing of restoration phases 1 and 2.**

Over this time period, wood rearranged slightly, as loose logs racked on wood jams. Based on repeat observations of the downstream-most wood jams in each study reach, I suspect that few to no logs mobilized downstream of the study reaches. These downstream-most jams did not mobilize or even significantly change during this period, and there were no signs that flow overtopped these jams sufficiently to transport logs over them. Some logs may have entered the upstream reach from upstream, but such input was not sufficient to substantially alter wood area in the reach.

Perhaps the most noticeable change, phase 2 restoration increased wood load by a factor of 4 in the upstream reach and a factor of 7 in the Budworm reach (Figure 13). This dramatic wood addition not only differed in quantity from phase 1, but also in its spatial pattern (Figure 15). Instead of placing wood as discrete jams, wood was placed in what I refer to as a wood lattice, or a wood assemblage characterized by high wood density (i.e., lots of wood per unit area), but a low degree of aggregation (i.e., spread out, not sorted into discrete jams).

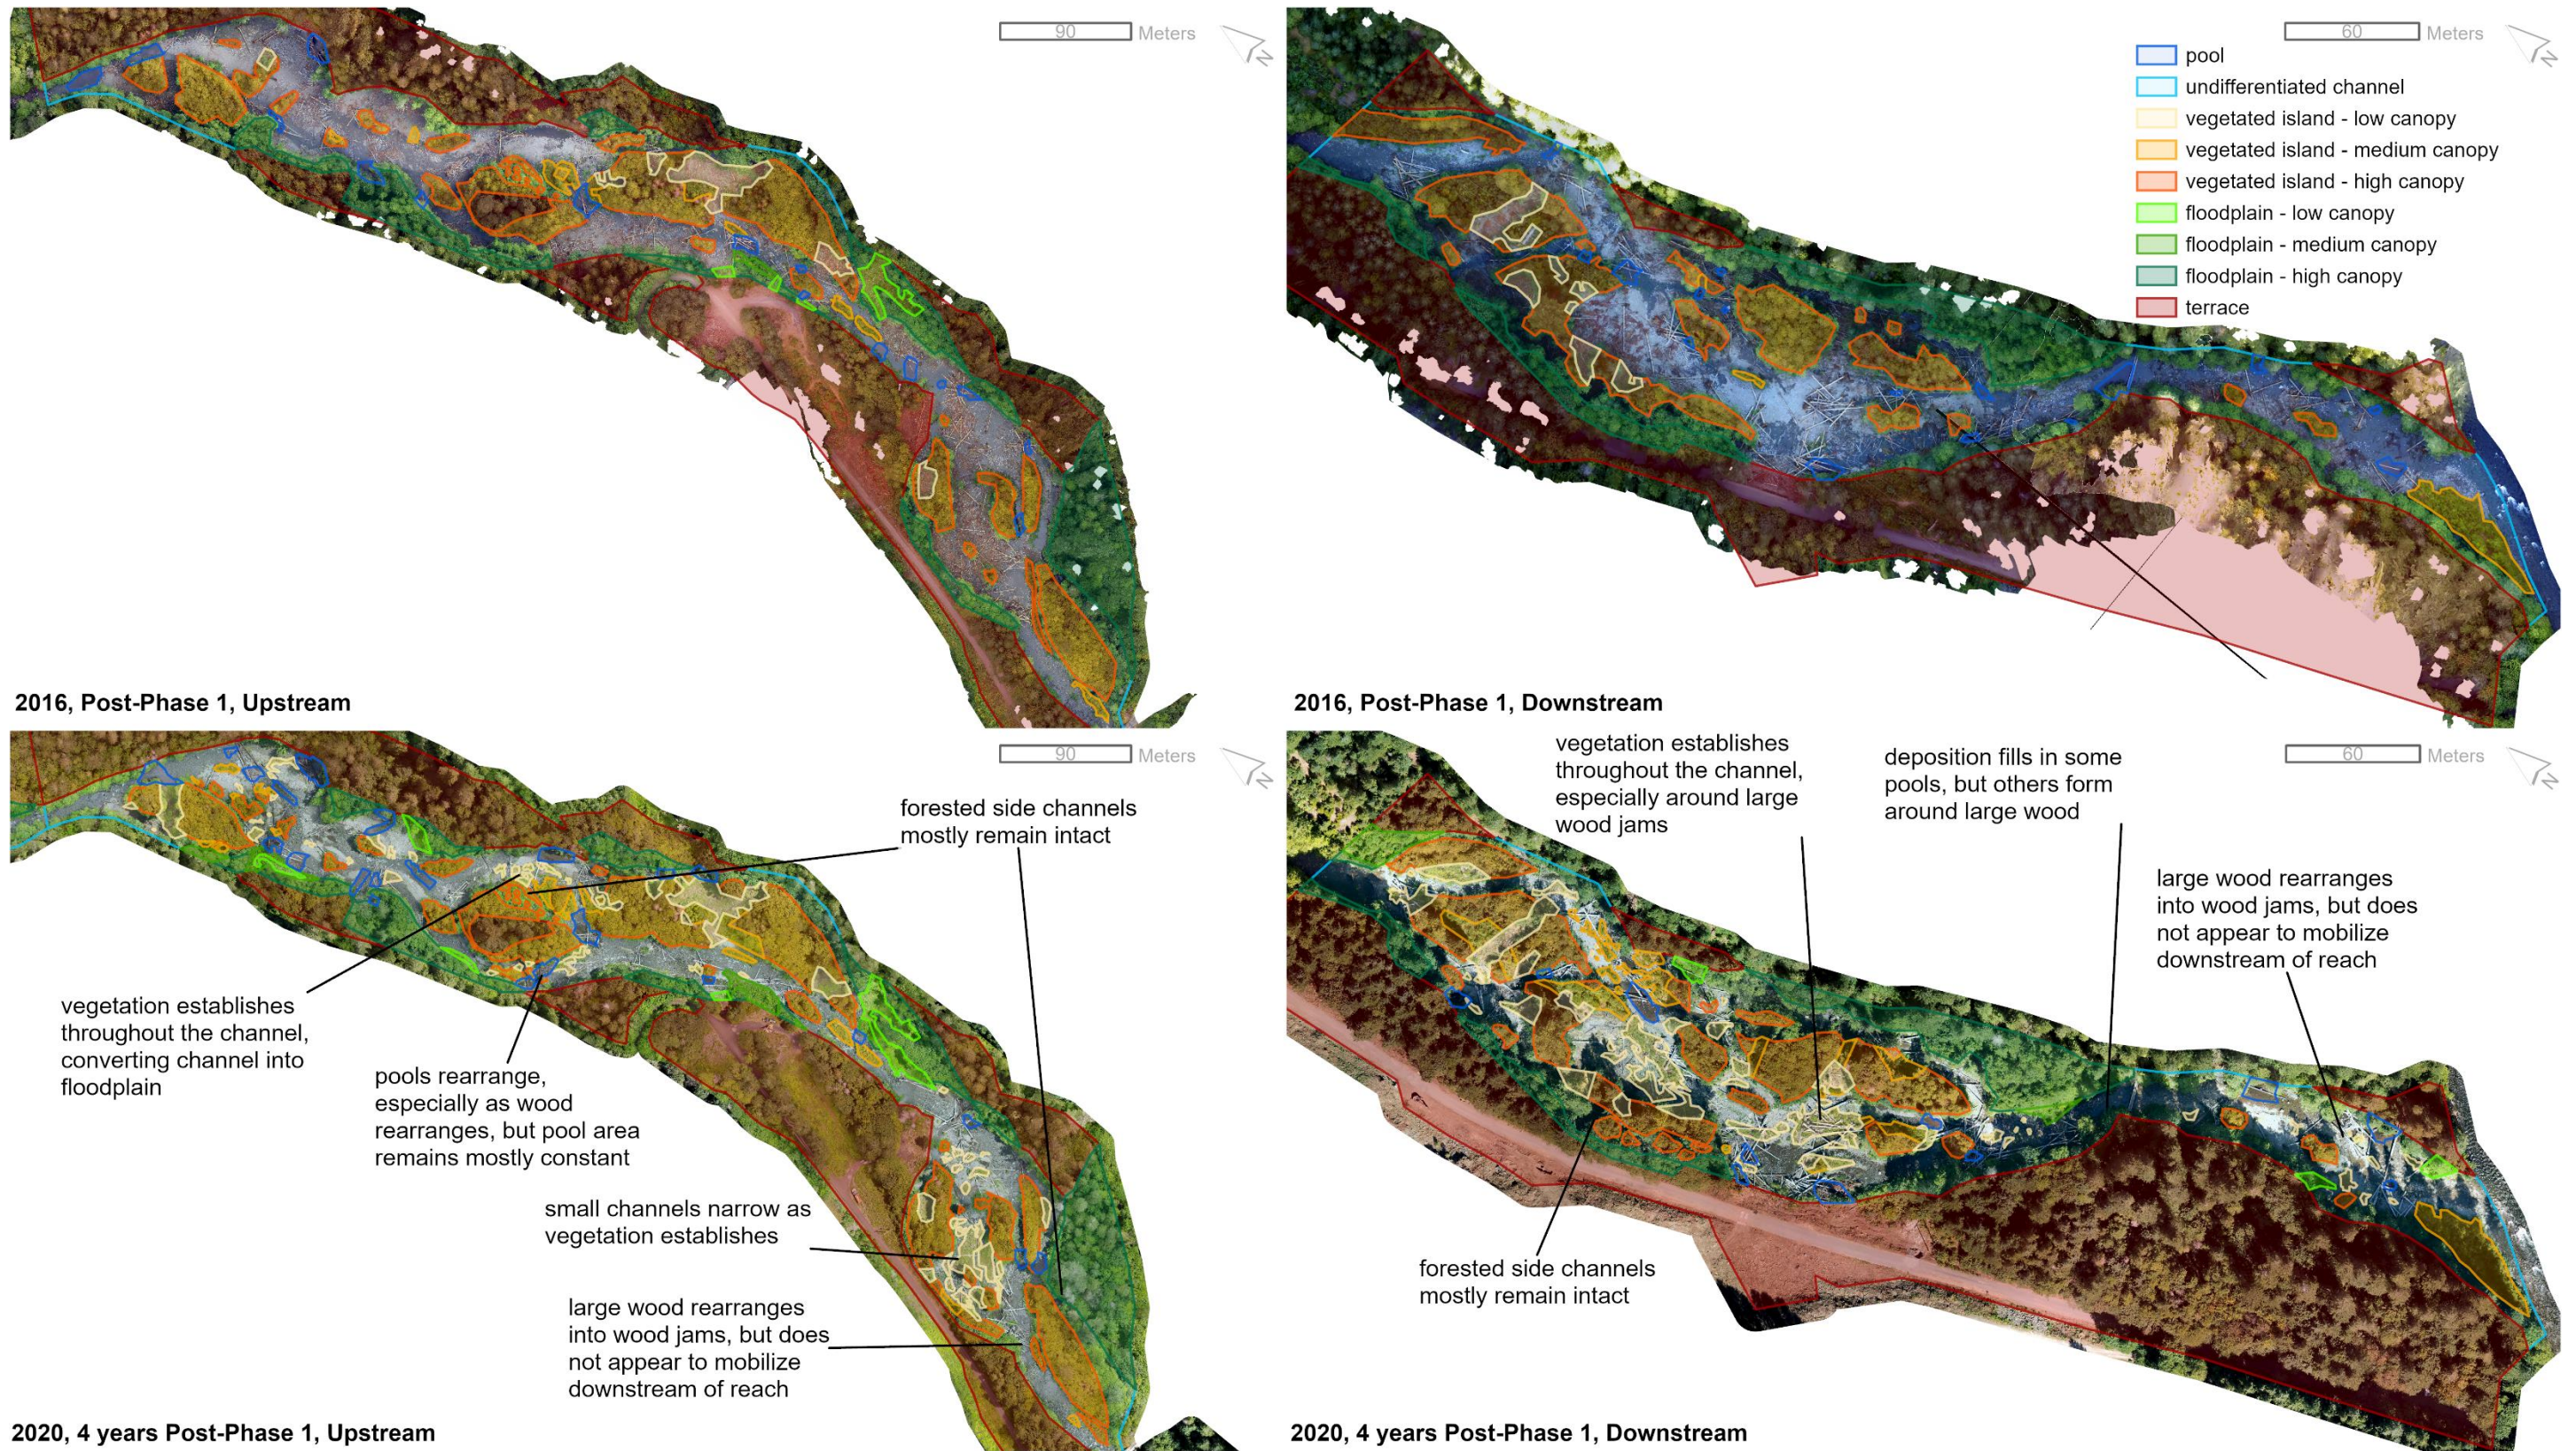
Figure 14: Geomorphic unit maps showing the restored reaches of Deer Creek just after phase 1 restoration and 4 years after phase 1 restoration (i.e., just before phase 2 restoration). Annotations show examples of how each reach evolved over this time period.

These changes are illustrated in Figure 14.

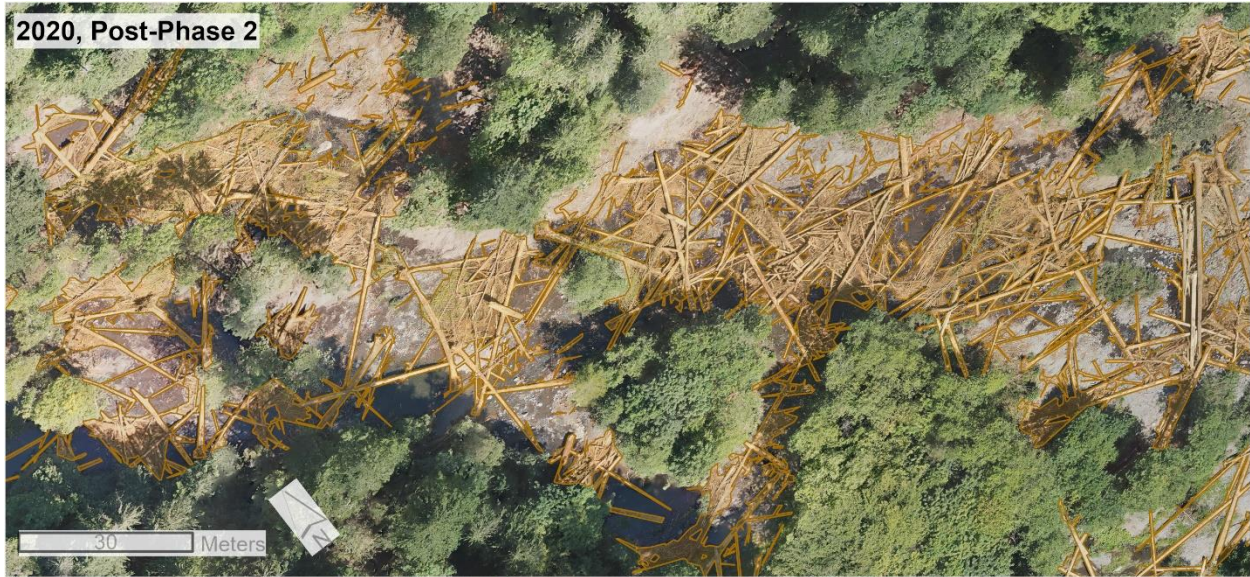
**Figure 15: Orthomosaic imagery showing the wood lattice placed as part of phase 2 restoration. Wood is highlighted in brown for clarity.**

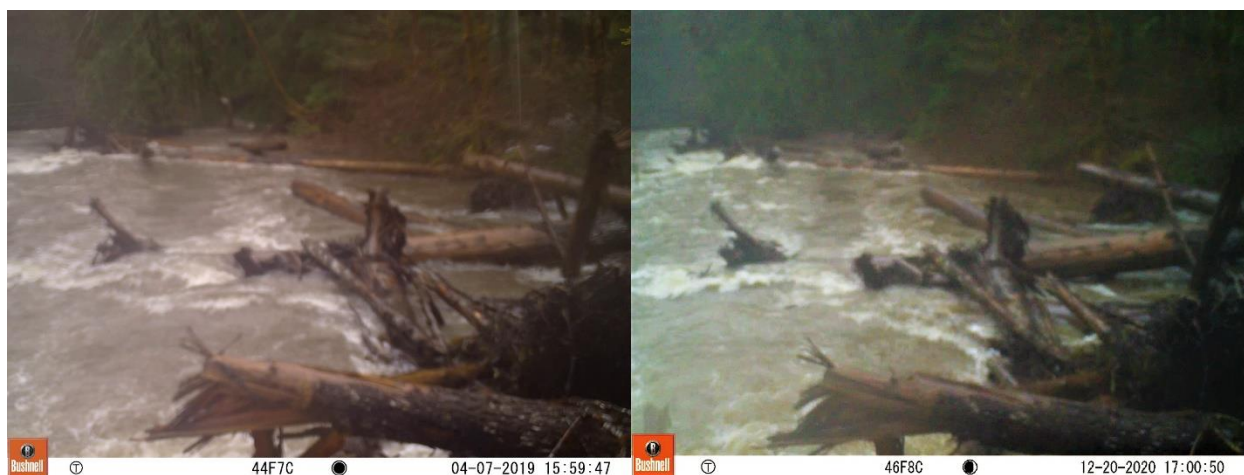
**Figure 17: Timelapse camera photographs in the downstream reach (unaffected by phase 2 restoration) from the April 2019 and December 2020 peak flows. Note that while flow stage only appears to be slightly lower in the December 2020 image, vegetation-induced roughness was likely considerably higher during that flow, so a given discharge would be expected to produce a higher stage during that flood.**

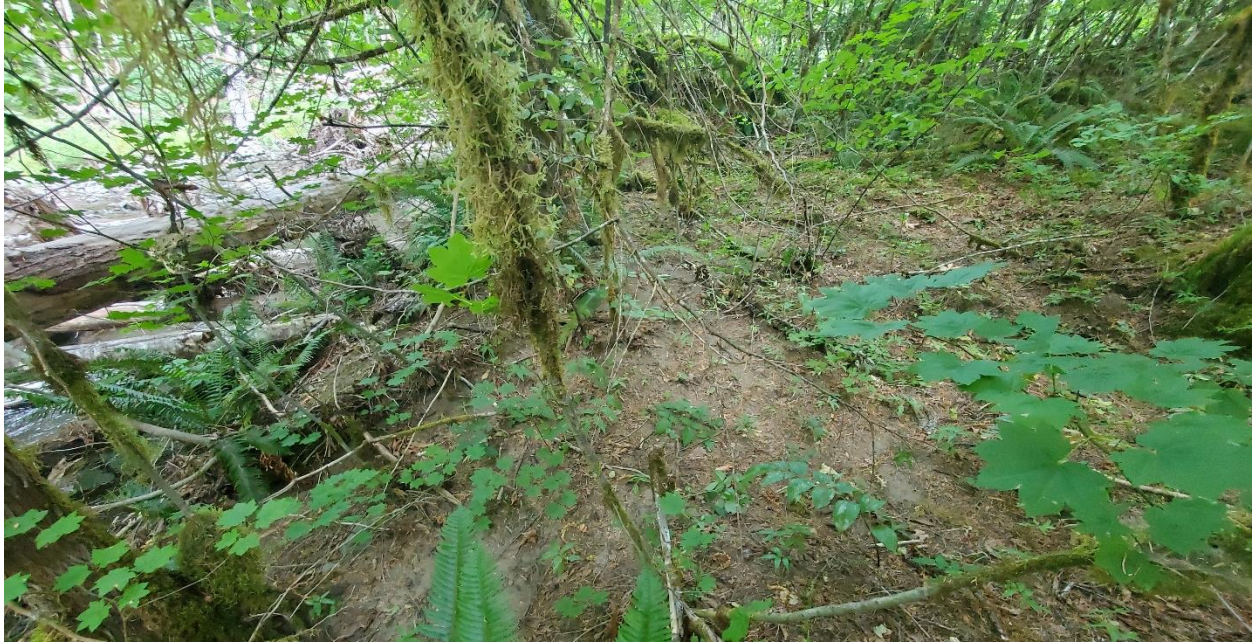
**Figure 18: Picture looking upstream on a floodplain with recent overbank sand deposition (August 2, 2021).**

In both the Budworm and upstream reaches, I found abundant evidence of floodplain inundation, including overbank sand deposition (e.g., Figure 18), leaves and sticks racked on living vegetation (e.g., Figure 19), channel incision into formerly unchanneled floodplain, scour and deposition on the floodplain, and channels that had been newly incised into floodplain and even terrace surfaces. This indicates substantial transfer of not only water, but also sediment and likely organic matter to the floodplain.

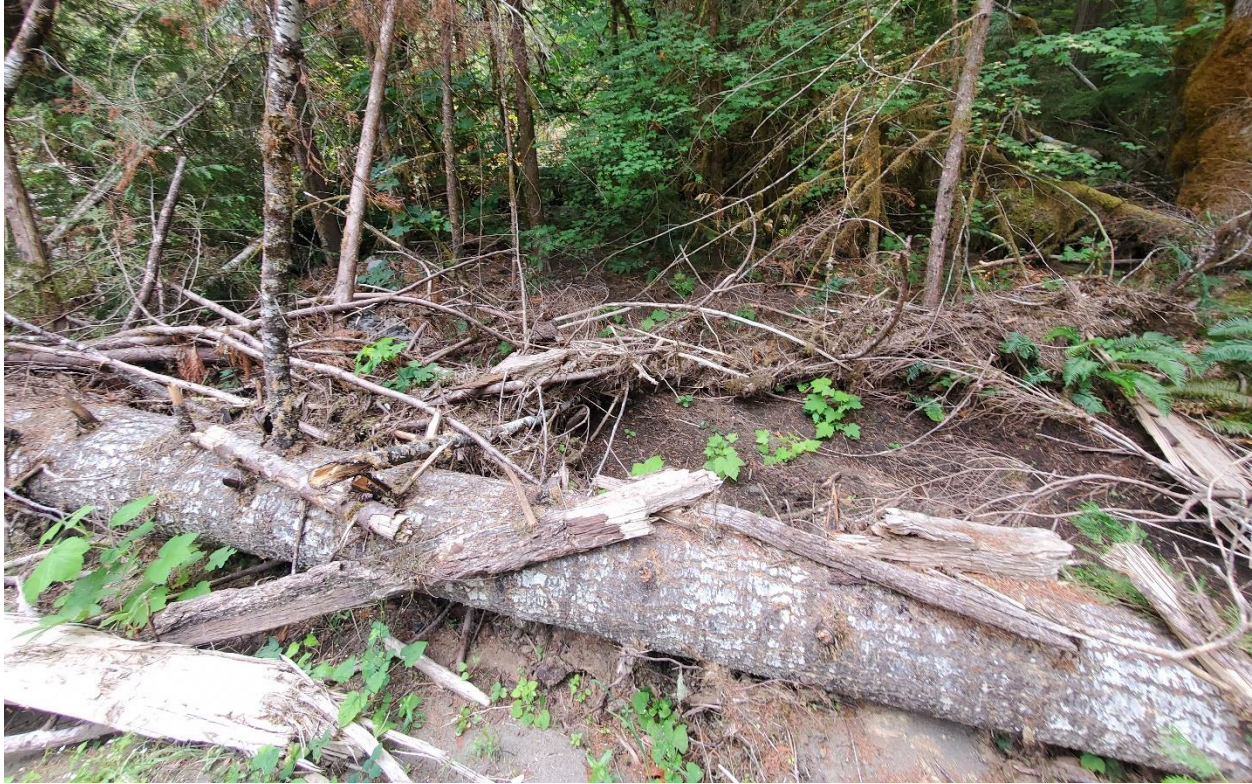
**Figure 19: Picture looking downstream at raked wood and fine organic matter on a floodplain margin, indicating inundation of the floodplain (August 3, 2021)**

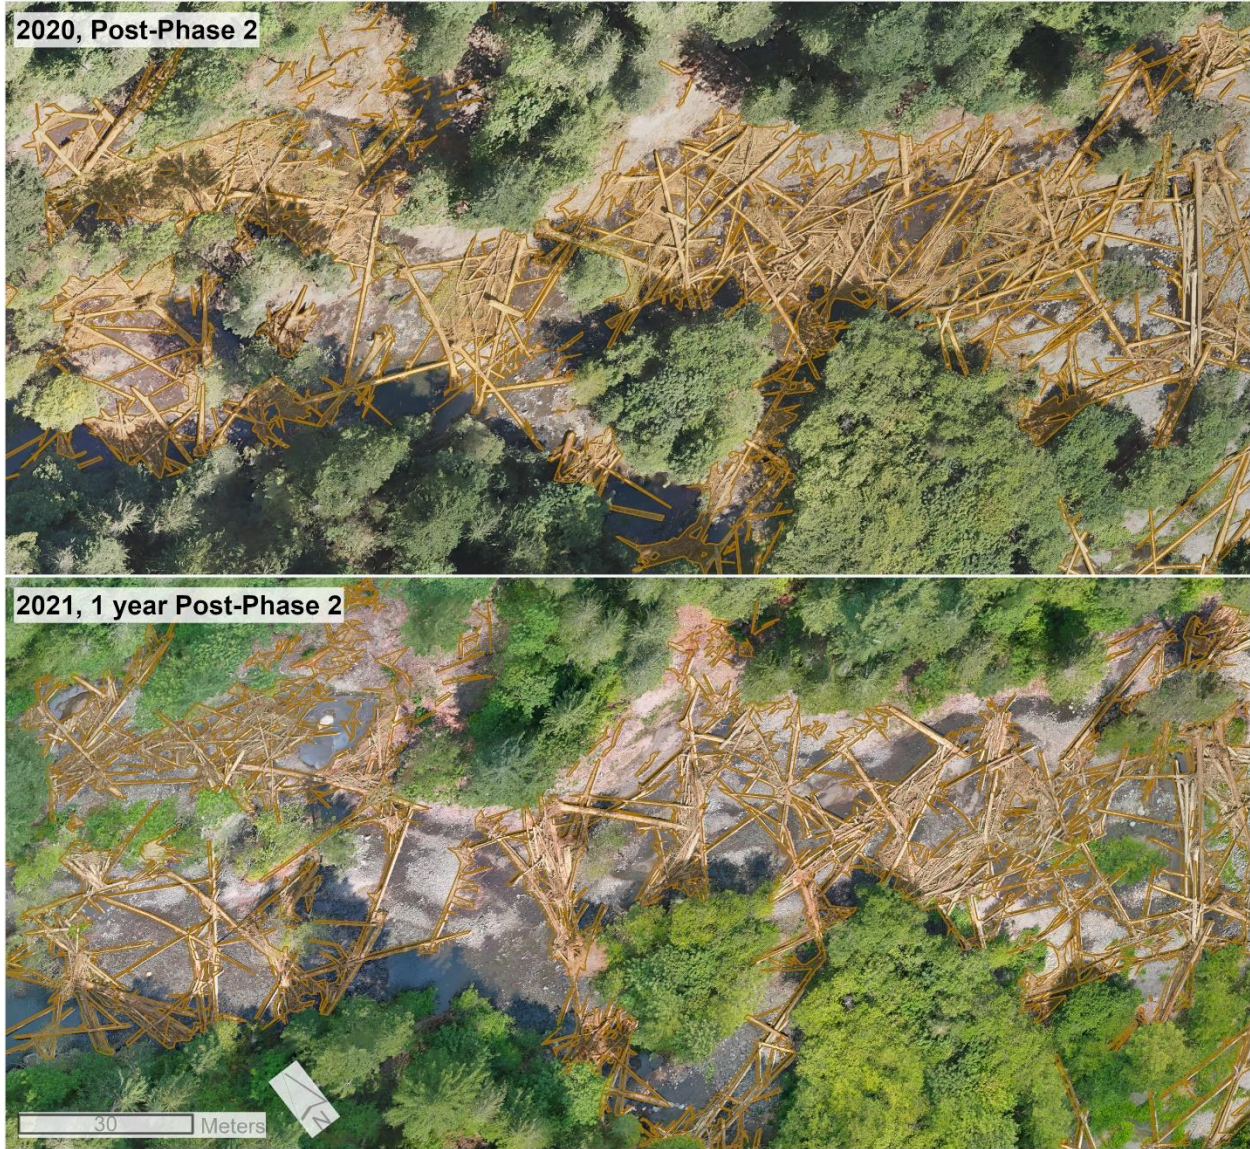
**Figure 20: Orthomosaic imagery showing wood rearrangement from just after phase 2 restoration to 1 year after phase 2 restoration. Wood is highlighted in brown for clarity. Note that while both images show a wood lattice, some discrete jams, or denser accumulations of wood, have formed in the lattice in the year following restoration.**

The large wood added during phase 2 restoration played a key role in the geomorphic evolution observed following restoration. While the initial placement took the form of a wood lattice, many logs in the lattice were transported downstream, racking on other logs and forming wood jams (Figure 20), overall decreasing the total wood area in both reaches (Figure 13). Based on timelapse camera footage (Figure 21), this rearrangement of wood occurred relatively quickly: during the peak flow on December 20, 2020, flow crested the approximate bankfull stage around 3:00am, and many of the logs visible in the timelapse frame had mobilized downstream by approximately 11:00am, while the flood waters remained elevated, likely near or above bankfull stage until 11:00pm that evening (Figure 22). This means that wood jams were formed with enough time for them to have a substantial effect on erosion and deposition. Wood rearrangement appeared to form more discrete jams in the Budworm reach compared to the upstream reach, possibly due to the narrower valley bottom in Budworm resulting in a higher flow depth (and thus a higher likelihood of log floating).

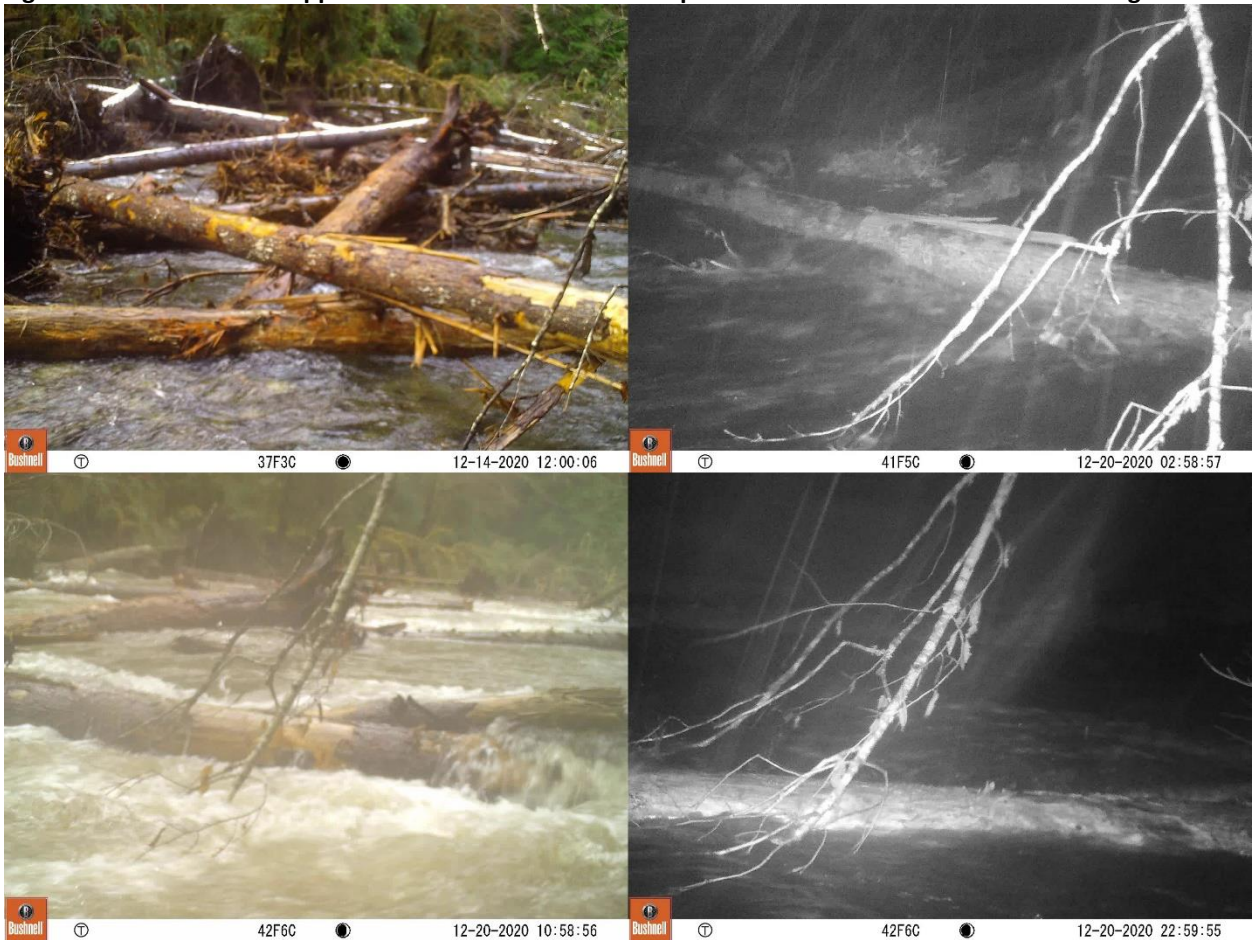
Figure 22: Timelapse stills showing wood reorganization during the December 20, 2020 flood.

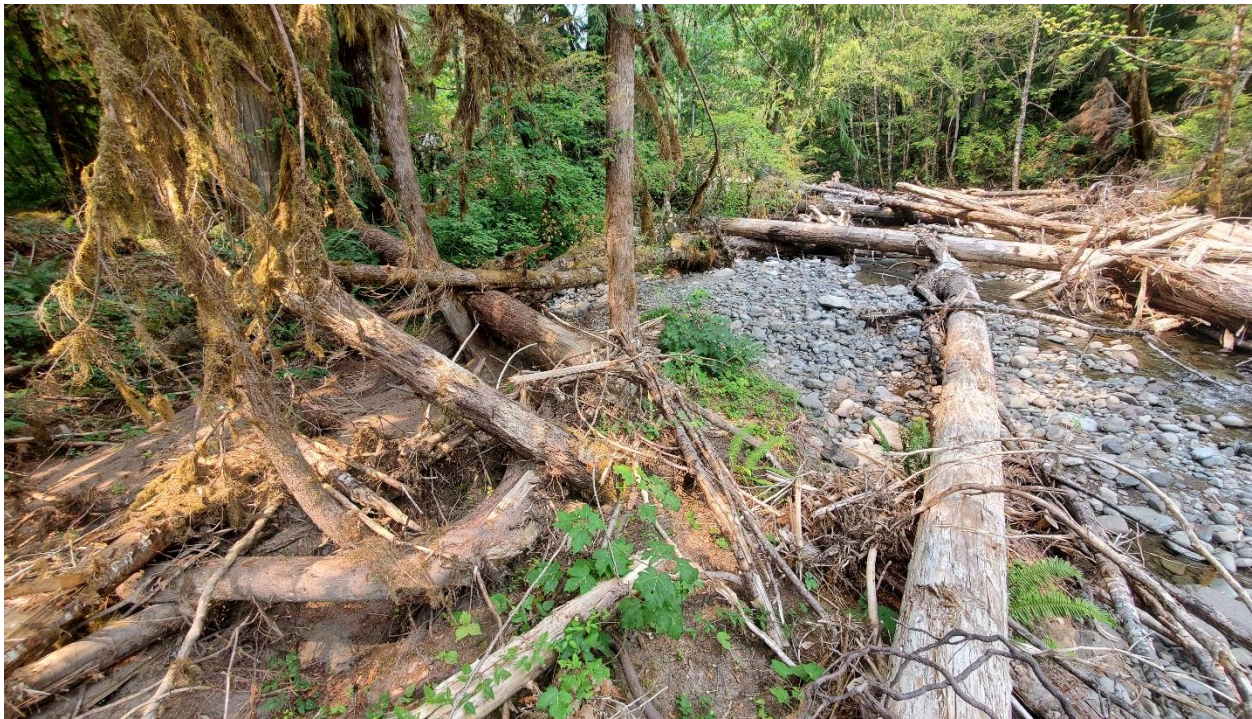
**Figure 23: Picture looking upstream at a newly formed side channel branching off into the floodplain (August 3, 2021).**

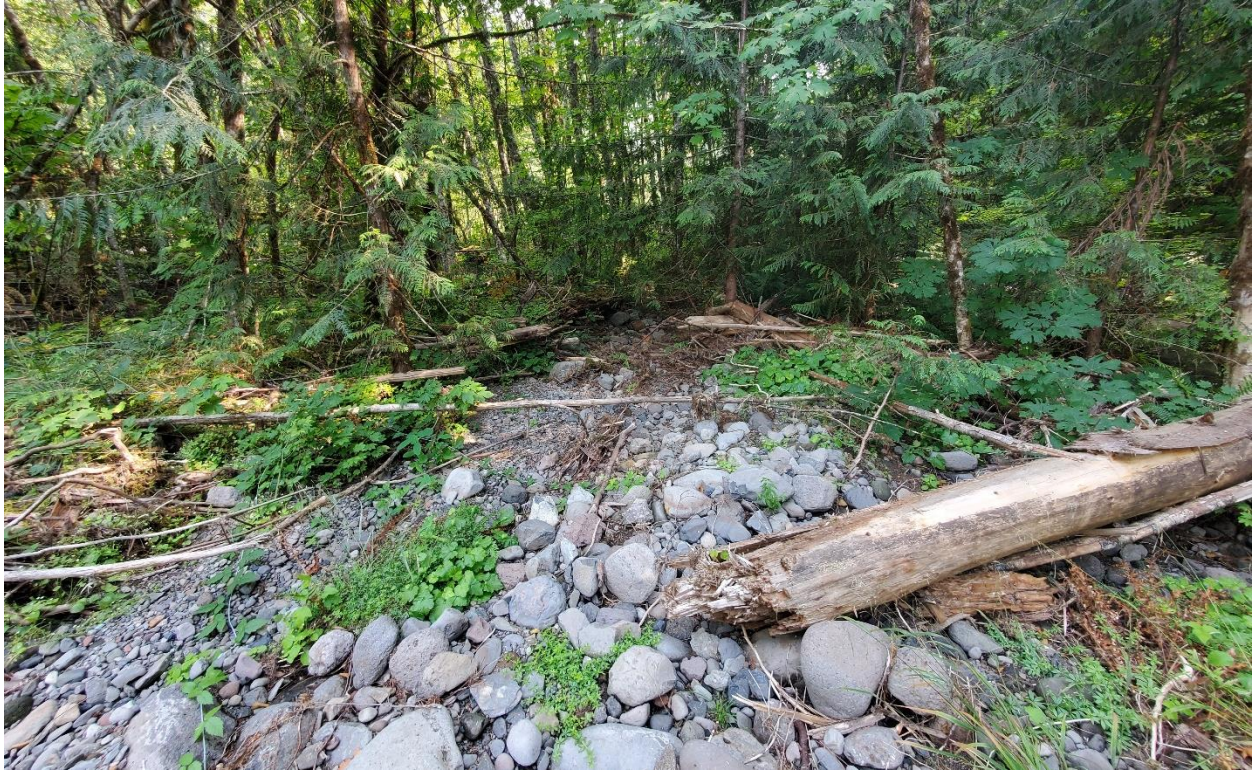
**Figure 24: Picture looking downstream at a channel inlet newly carved into a former floodplain surface (August 2, 2021).**

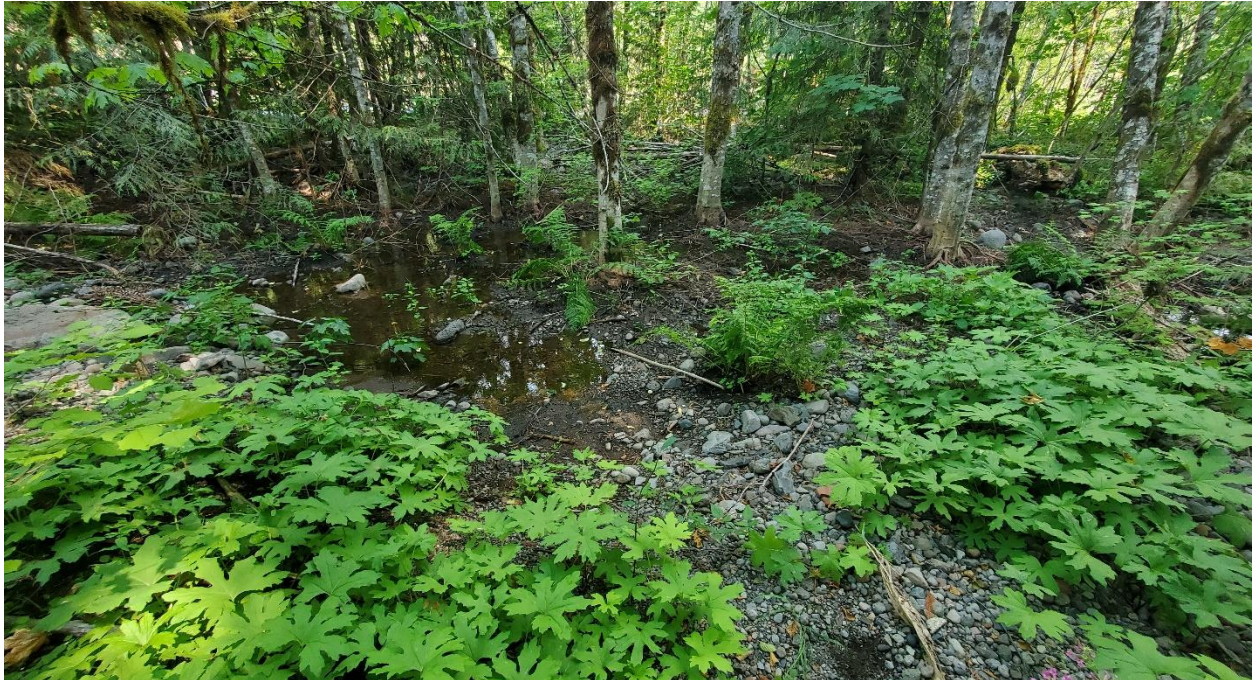
**Figure 25: Picture looking left at a newly scoured area wetted at low flow on what was formerly a floodplain surface, taken just downstream of Figure 24 (August 2, 2021).**

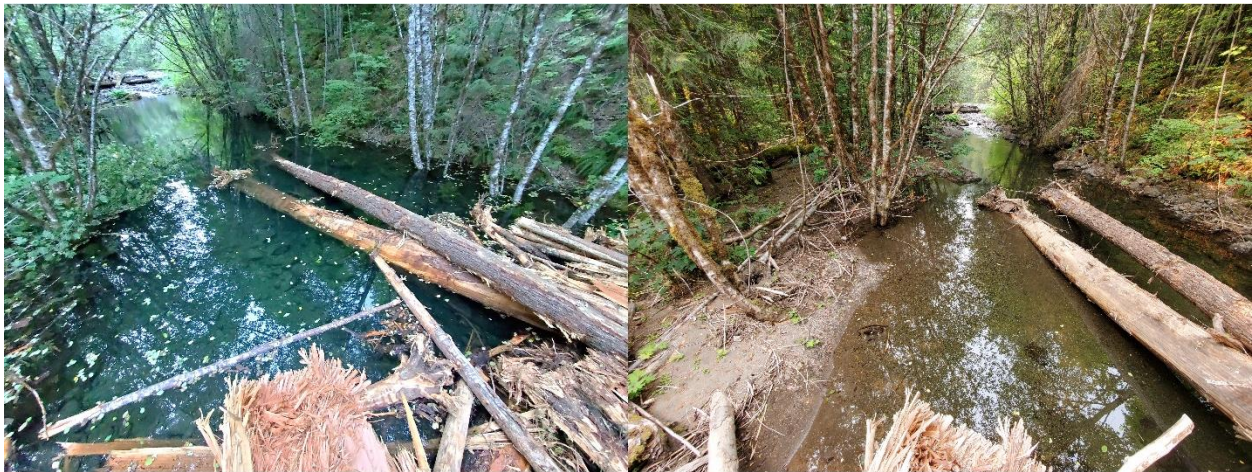
**Figure 26: Repeat photographs looking upstream from the upstream-most wood placement in the Budworm reach. Compare bed conditions from August 29, 2020 (left, dominantly cobble bed), to August 3, 2021 (right, dominantly sand to gravel bed).**

The higher in-channel roughness provided by large wood and flow spreading out over a wider area also appeared to induce substantial gravel deposition (e.g., Figure 26). However, significant trends in bed surface grain size were difficult to distinguish (see Appendix 3).

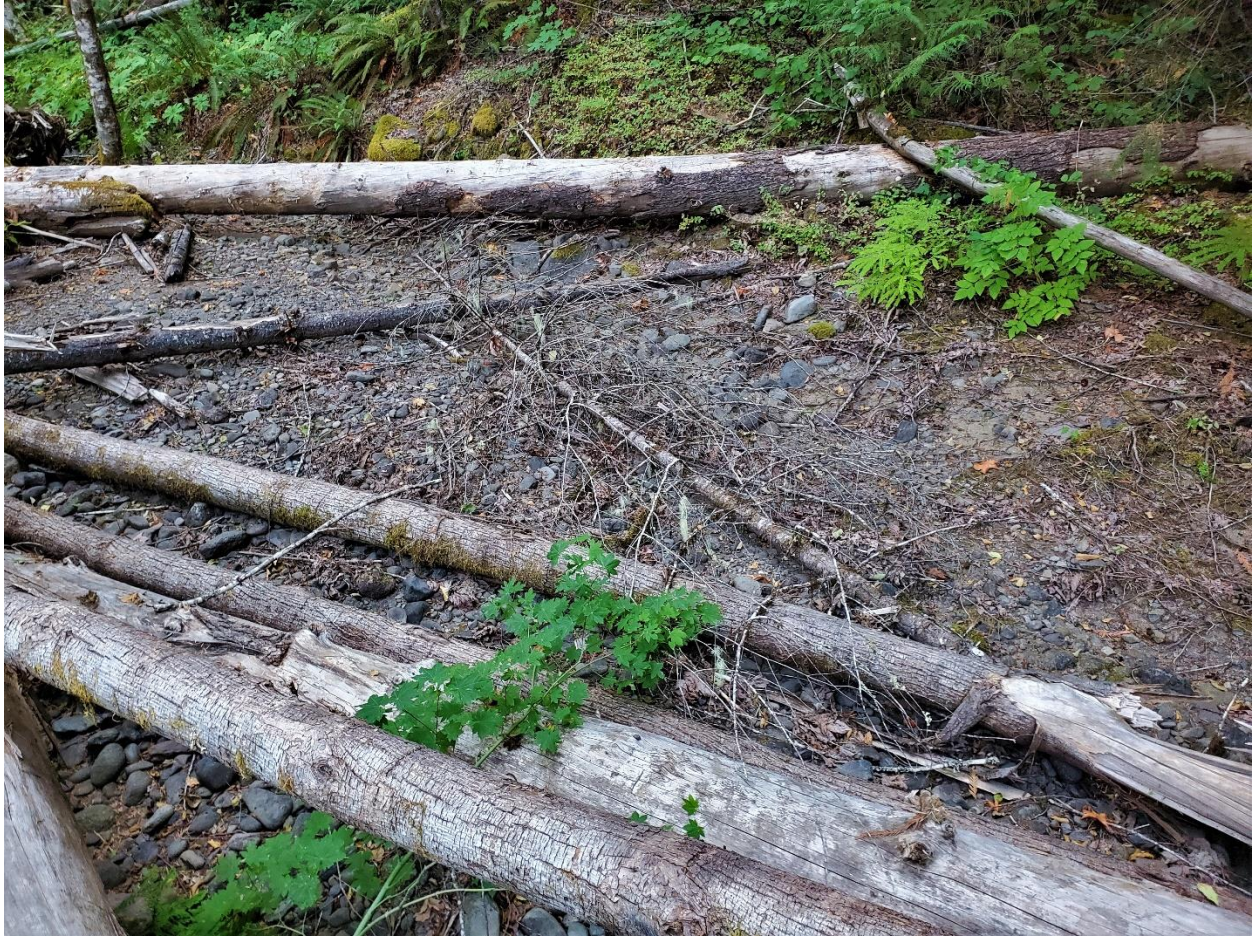
**Figure 27: Picture of the left forested channel across from the hairpin turn in forest road 782 looking upstream (August 4<sup>th</sup>, 2021). Note the fallen leaves in the channel that have not been moved significantly by flow.**

One notable exception to the pattern of substantial reworking of the valley bottom was the left side of the channel in the upstream reach across from the hairpin turn in forest road 782. Here, a forested channel appeared to have not been inundated with flow sufficient to move the leaves and other fine organic detritus laid down in Fall 2020 (Figure 27). This indicates a transition from channel to floodplain in this area, as many other forested channels upstream, downstream, and across the valley bottom from this location were inundated during the last high flow enough to move fine organic detritus. This now relict channel is in one of the widest portions of the valley bottom, where a substantial amount of formerly floodplain surface was turned into channel by phase 2 restoration. It is possible that in this area, clearing rightward of this channel was sufficient to divert flow away and towards the right side of the valley bottom, even during a flow that overtopped the banks along most of the valley bottom.

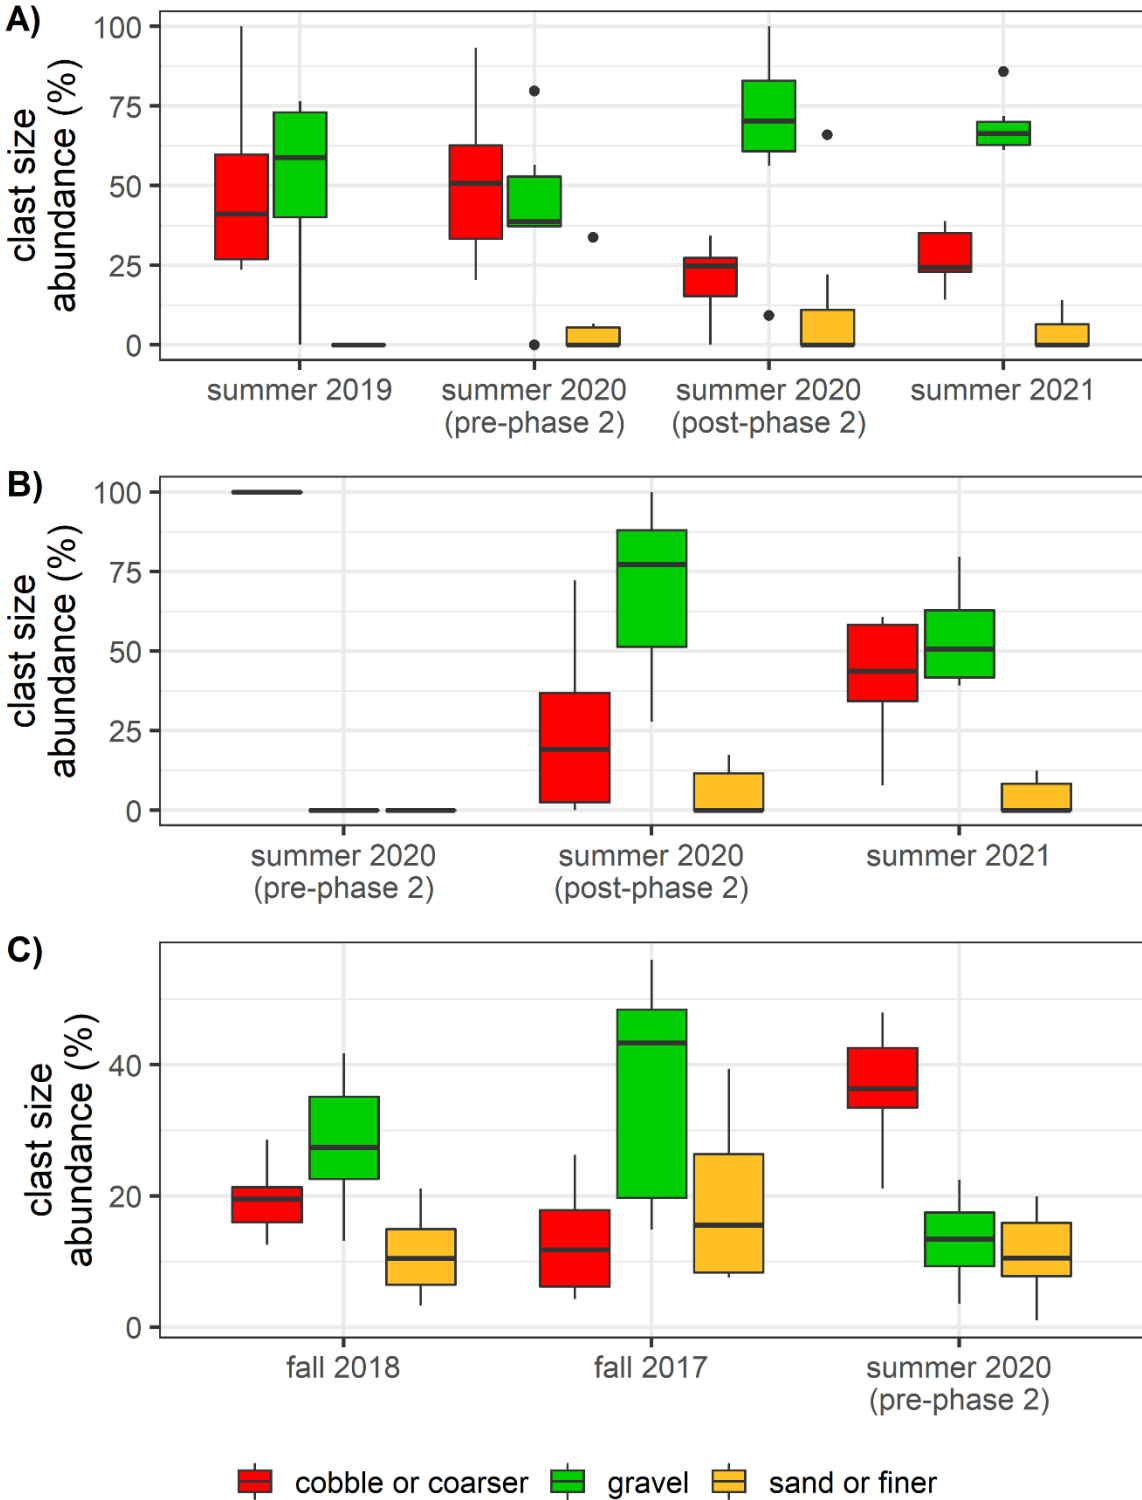
**Figure 31: Boxplots summarizing transect-based survey data for my transects in the upstream reach (A) and Budworm reach (B) and Forest Service transects in the upstream reach (C). Bold horizontal line indicates median, box indicates 25<sup>th</sup> to 75<sup>th</sup> percentiles (i.e., interquartile range), lines indicate 1.5 times the interquartile range, and dots indicate observations outside 1.5 times the interquartile range.**

The data from these transect surveys displays a high degree of variability, likely due to a low sample size. As such, it is difficult to discern significant trends in bed grain size from these data. However, I present them here for informative purposes (Figure 31).
