Stage Zero/Eight Restoration Road Trip: April 2024

Ray J. White, Owner, Trout Habitat Specialists, Edmonds, WA <u>rw@seanet.com</u> Tracy Hames, Executive Director, Wisconsin Wetlands Association <u>tracy.hames@wisconsinwetlands.org</u>

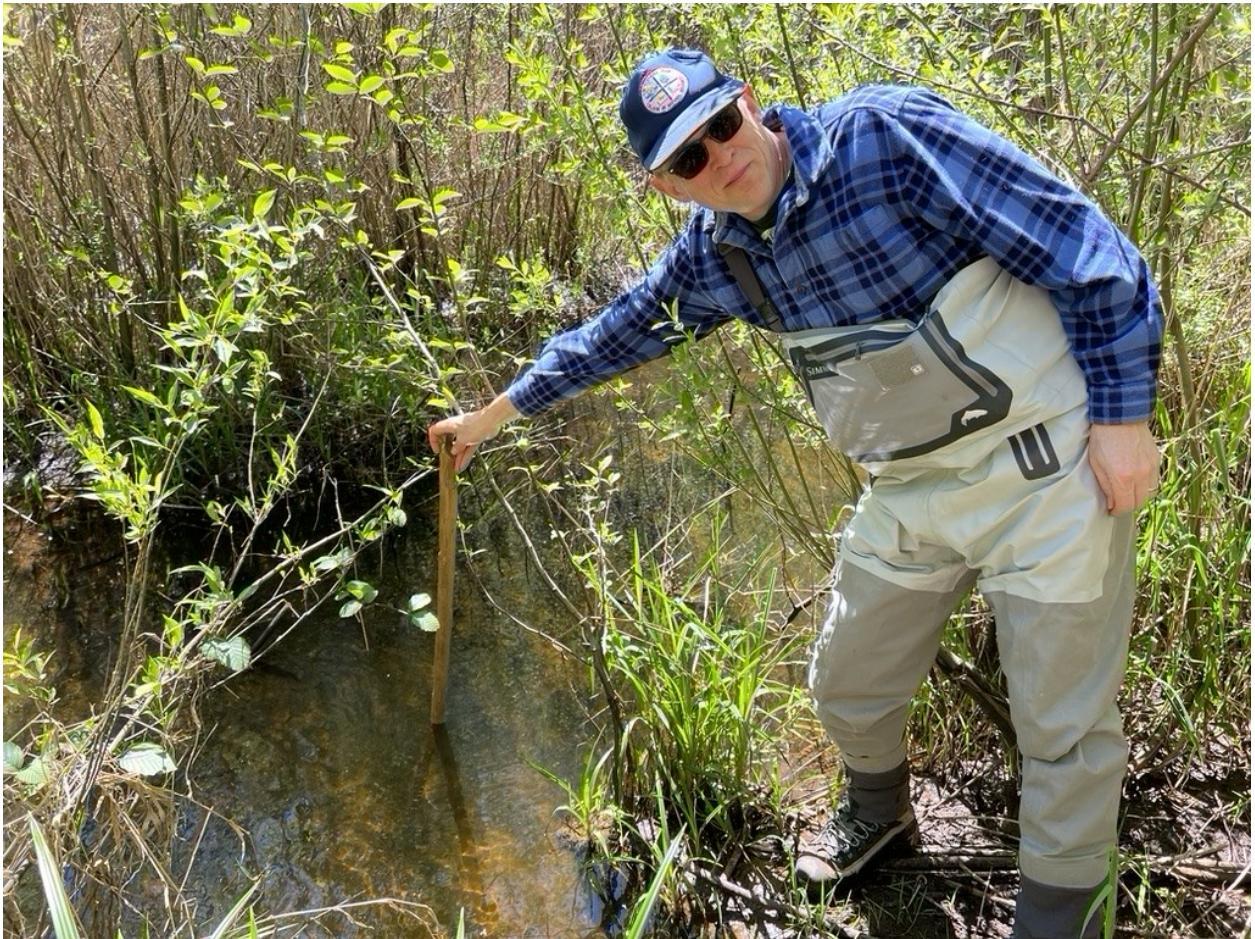
Figure 1. Paul Burns showing a deep pool in one of several narrow anabranches in a reach of Fivemile Creek restored to Stage Zero.

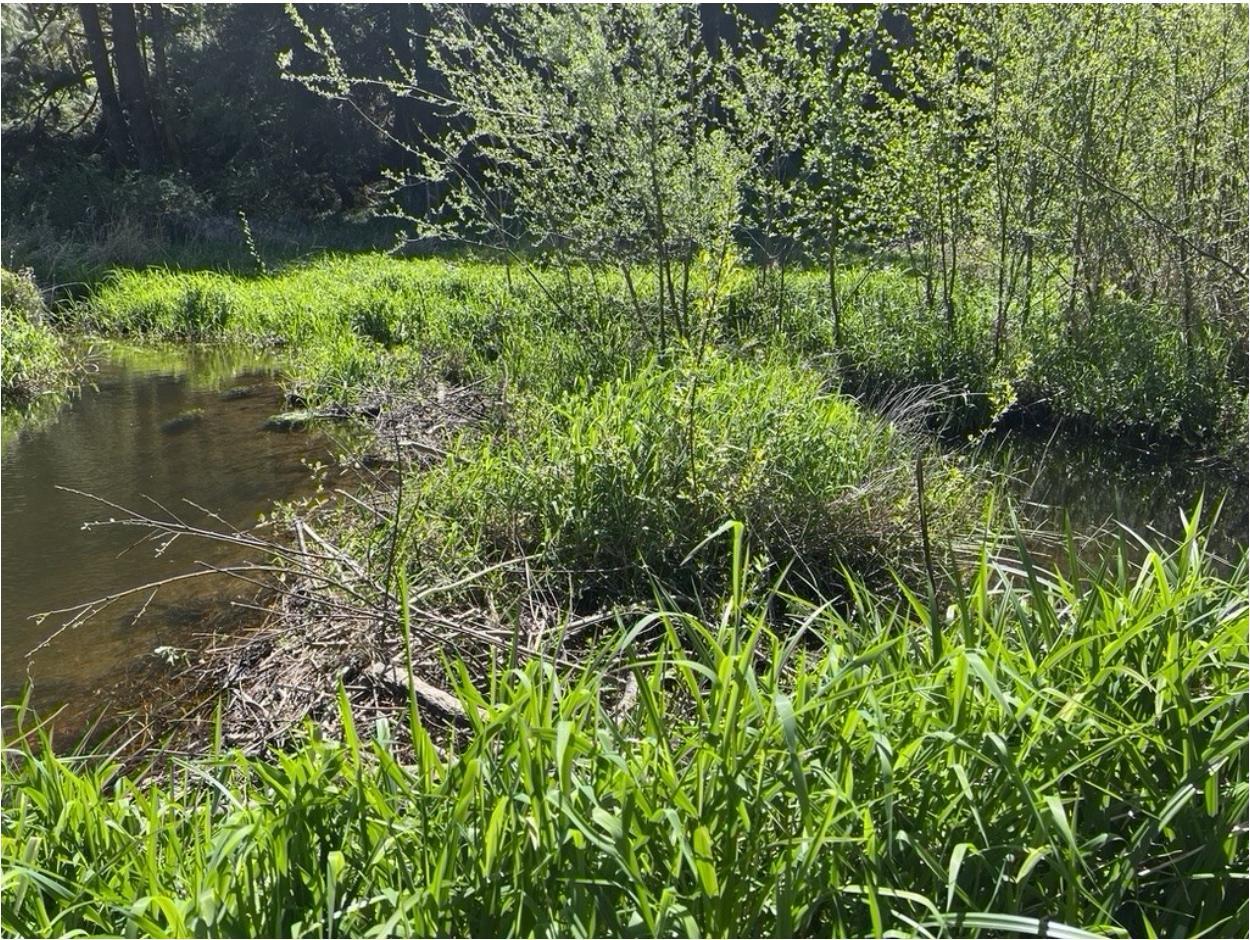
Figure 2. With the floodplain reconnected and runoff energy reduced, beavers have returned to this section of Fivemile Creek, further increasing diversity and dynamism in this low gradient stream beyond that generated by vegetation regrowth alone.

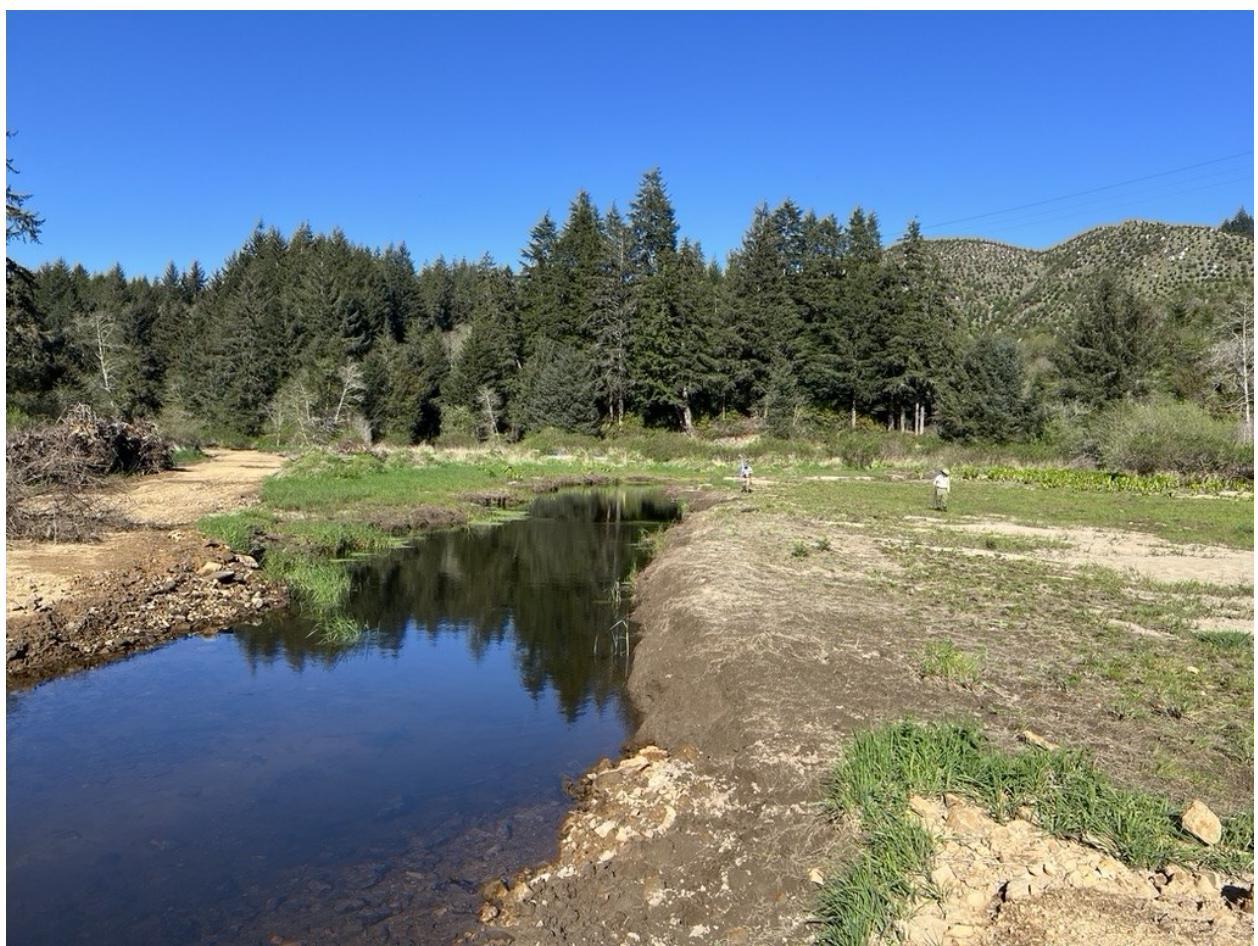
Figure 3. A ditched portion of Fivemile Creek scheduled soon to be filled with post-European legacy sediments scraped off the floodplain. Contrast this reach with the restored conditions in Figures 1 & 2.

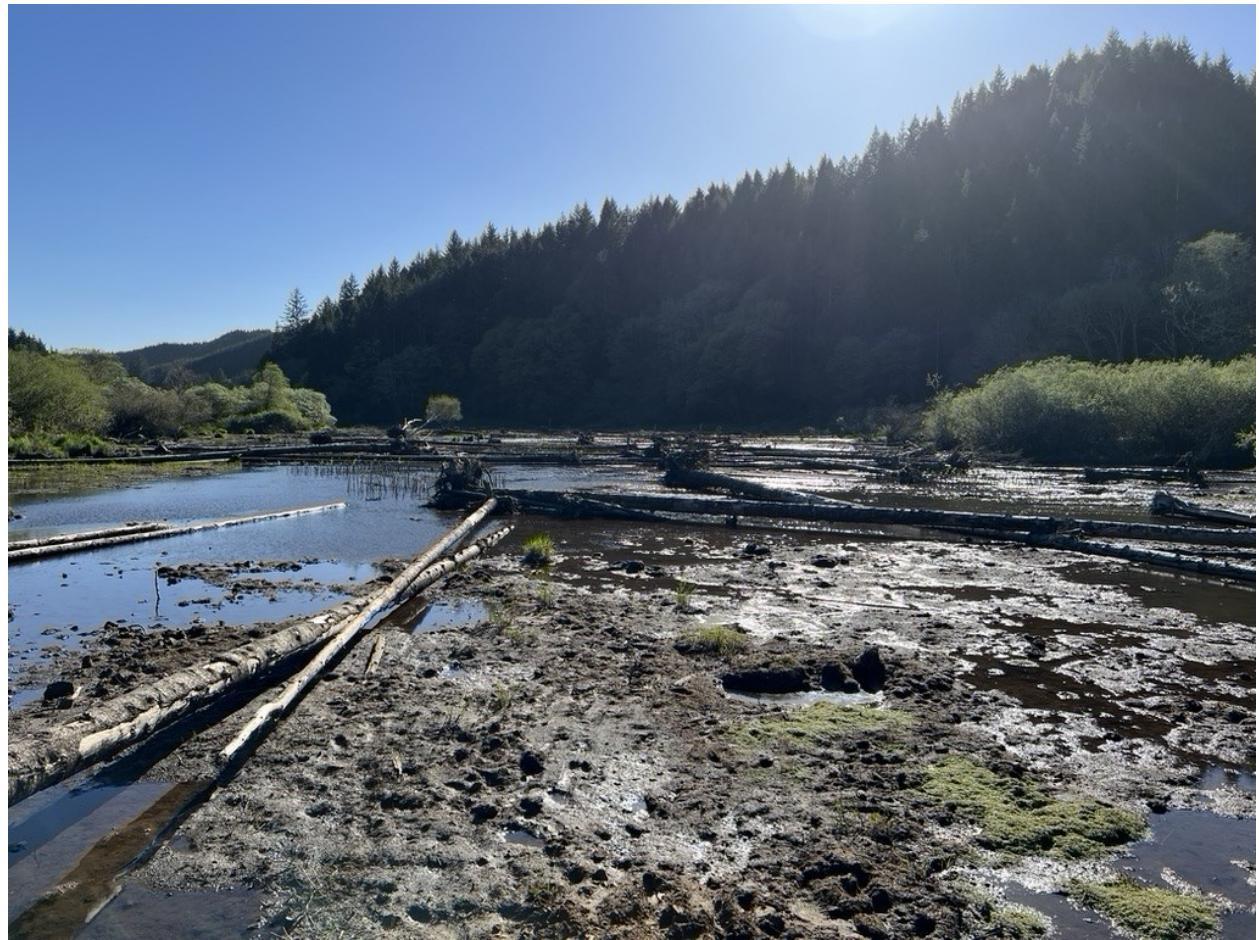
Figure 4. In this reach of Fivemile Creek, post-development alluvium has recently been removed, large wood has been placed, and vegetation re-establishment has just begun. Based on experience gained upstream, this reach will become a multi-channeled, willow 'carr' (i.e., a wet woodland) within a few short years.

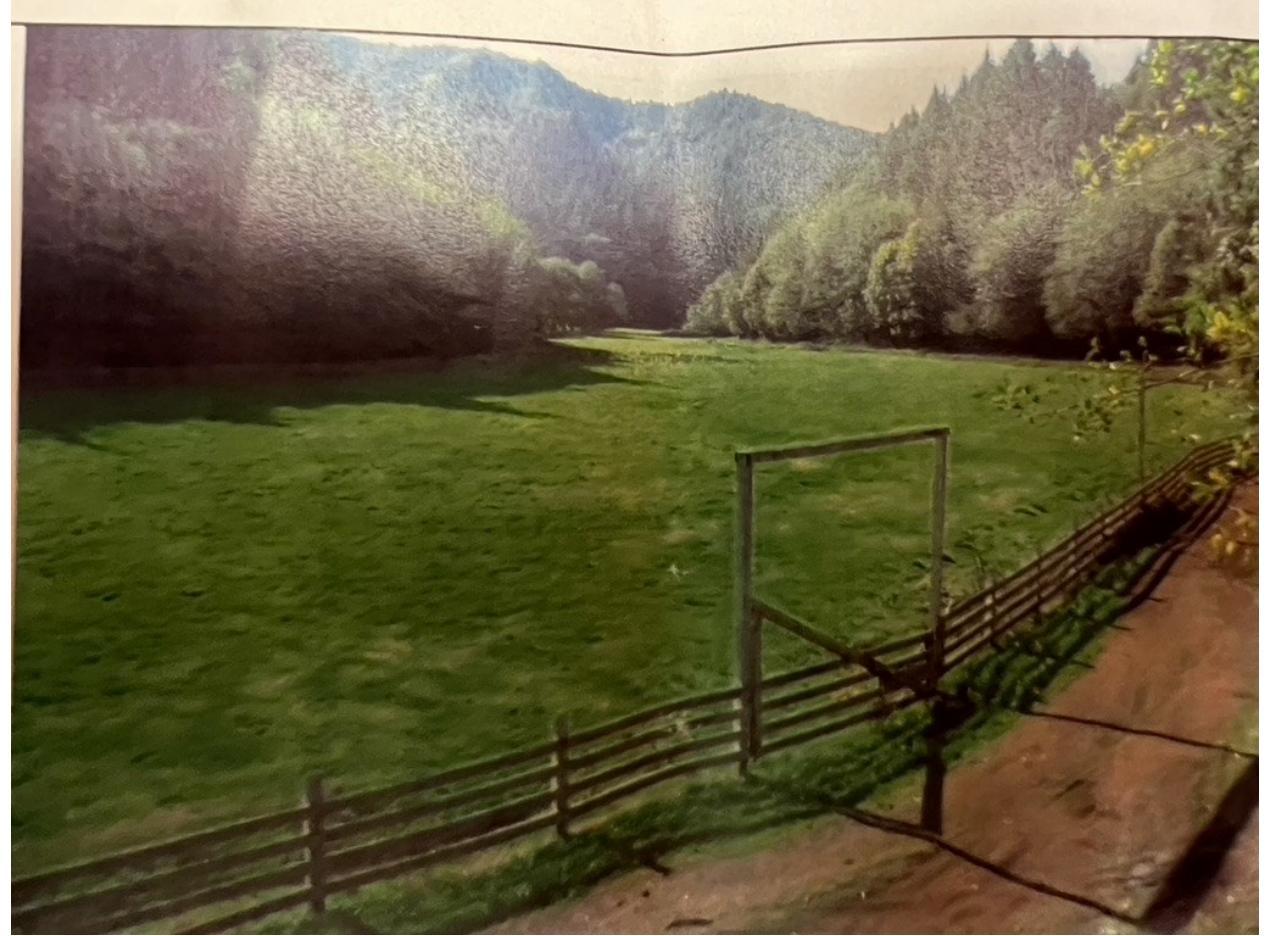
Figure 5. A pre-restoration photo. of Fivemile Creek. Prior to restoration, the creek had been channelized and moved to the far edge of the historic floodplain.

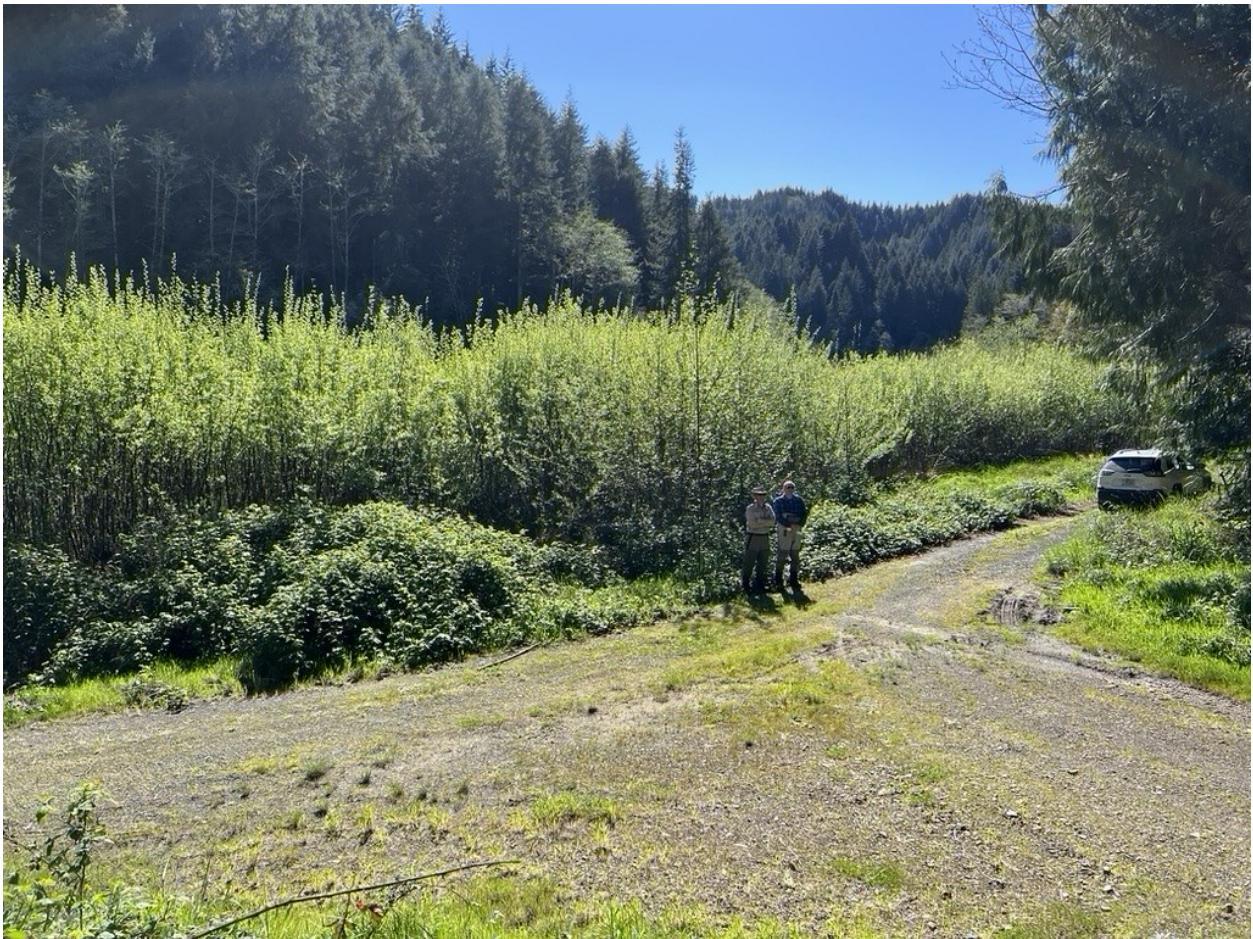
Figure 6. The same location as Figure 5, post-restoration (April 2024). The gate in the previous photo was located where Colin Thorne and Paul Burns are standing.

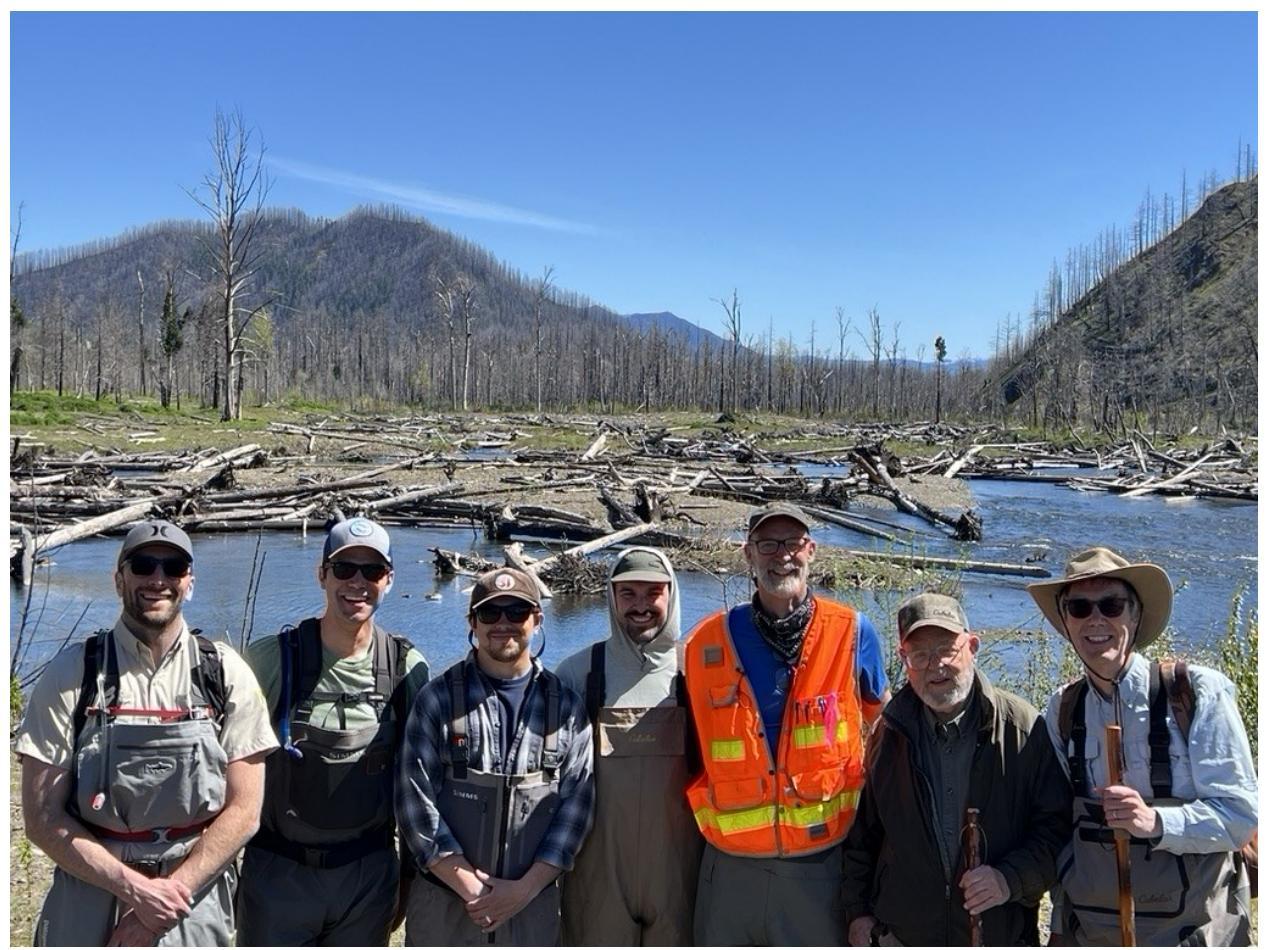
Figure 7. Several of the partners who hosted our visit to the Stage 8, reconnected floodplain on the Middle McKenzie River at Finn Rock. Note the massive amount of large wood placed in the site, and the live willow and other riparian plantings throughout the lowered and rewetted floodplain. The standing dead trees are the result of the Holiday Farm wildfire that swept through the area in 2020. Left to right: Andy Spyrka (ODFW), John Trimble (McKenzie River Trust), Logan Bodiford (USFS), Will l'Hommedieu (USACE), Johan Hogervorst (USFS), Ray White and Colin Thorne.

altered by decades of human actions. Combined effects of upper watershed disturbance, vegetation removal and alteration, channel simplification to improve navigation, levee building, and other actions had simplified this reach of the mainstem river. The results included a much drier river corridor, loss of wetland and multi-channel habitats, warmer summer flows, higher-energy flood flows, channel incision, and great loss in biodiversity/productivity. Restoration involved, (i) removing post-development deposition to lower a portion of the former floodplain and reconnect it to the incised mainstream (generally referred to as Stage 8 in the Stream Evolution Model), (ii) using the removed material to fill a large, abandoned gravel-pit and several incised side-channels, (iii) placing massive amounts of large wood throughout the project area, and (iv) allowing natural floodplain processes and vegetation (partly from extensive plantings) to do the rest. The result is a multi-channel river corridor, an increase in the wetted perimeter, and a rough and messy floodplain that is reconnected to the river at base flow (https://mckenzieriver.org/finn-rock-restoration-complete/).

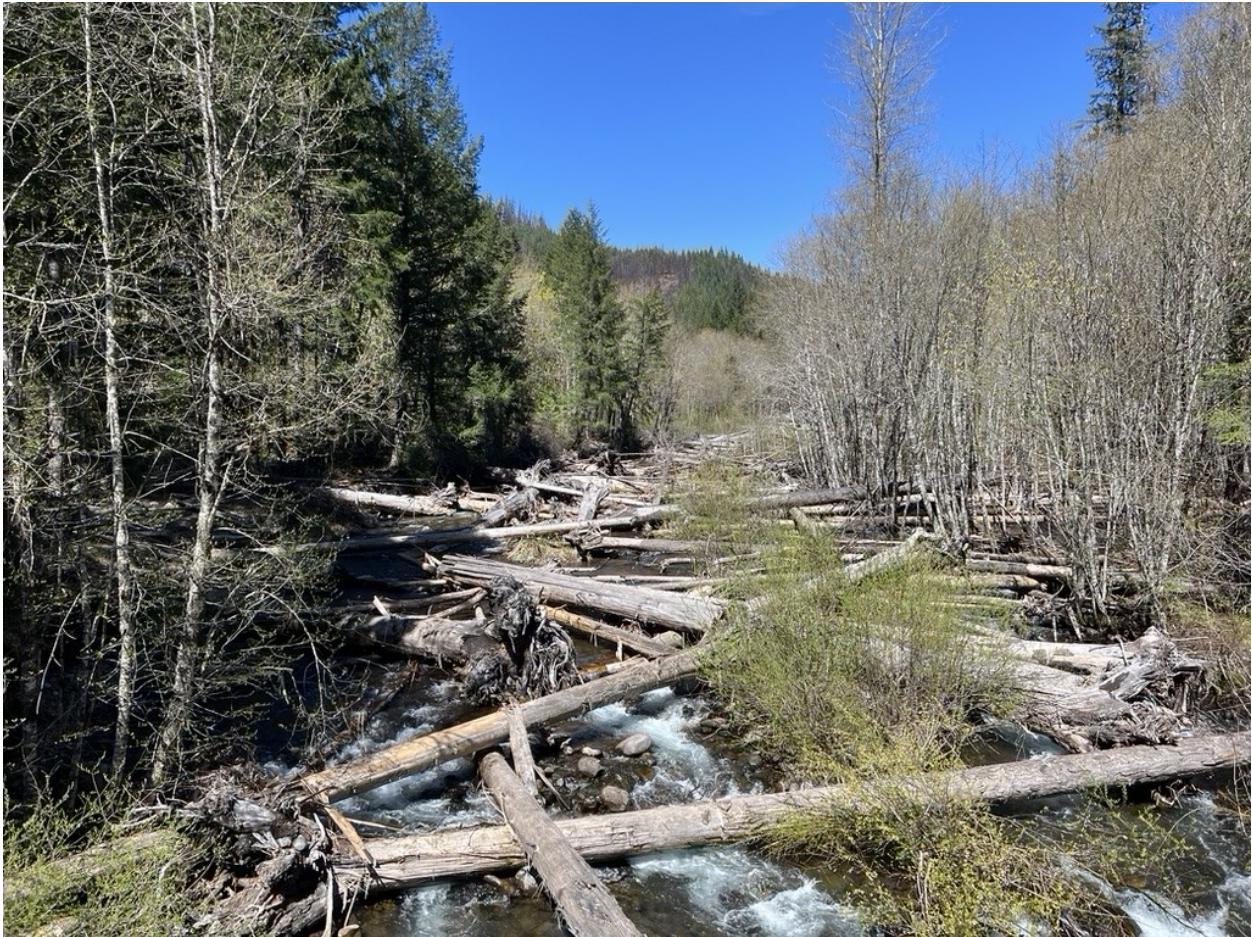
Figure 8. In Deer Creek, a very large amount of large wood has been placed to provide friction against the flashy, high energy flood flows that this steep McKenzie River tributary experiences. A good channel-floodplain system is messy, rough, and complex.

Viewing nearby Deer Creek introduced us to a situation requiring a different approach to restoration. The reach of Deer Creek (a steep tributary to the McKenzie River) we visited had experienced logging and channelization followed by installation and maintenance of powerlines and a main road, all directly within relatively narrow the valley floor. In this small watershed, the great storm of 1964 created a 'firehose' that flushed out alluvial sediments and wood, in places scoured to bedrock. The initial remedy here involved replacing a key element – very large wood (https://usfs.maps.arcgis.com/apps/Cascade/index.html?appid=a1eab14df971439580ac2c17e308f a09). One of the lessons learned during the first phase of restoration and applied during the later phases was to add a range of large wood sizes, including plenty that the creek can mobilize to form natural log jams that increase morphological, sediment, and habitat diversity. Placing large wood in Deer Creek in this manner is allowing the Creek to do the bulk of the restoration work. High flows mobilize the wood over time, distributing the added pieces naturally, forming log jams, pools, and sediment patches in locations where the creek places them. This ensures that the right amounts, of the right kinds of wood, are deposited in the right locations. Morphology, sediment, and habitat diversity are increasing, but at Nature's pace.

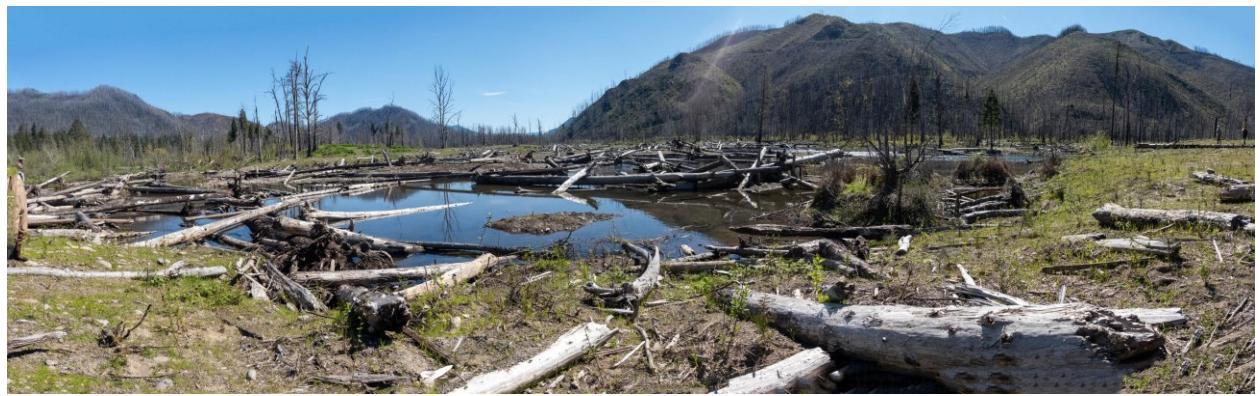
Figure 9. As illustrated here in the Finn Rock reach, the immediate result of restoration to Stages 0 or 8 using the 'valley flood reset' approach is a very wide and wet river-floodplain corridor.

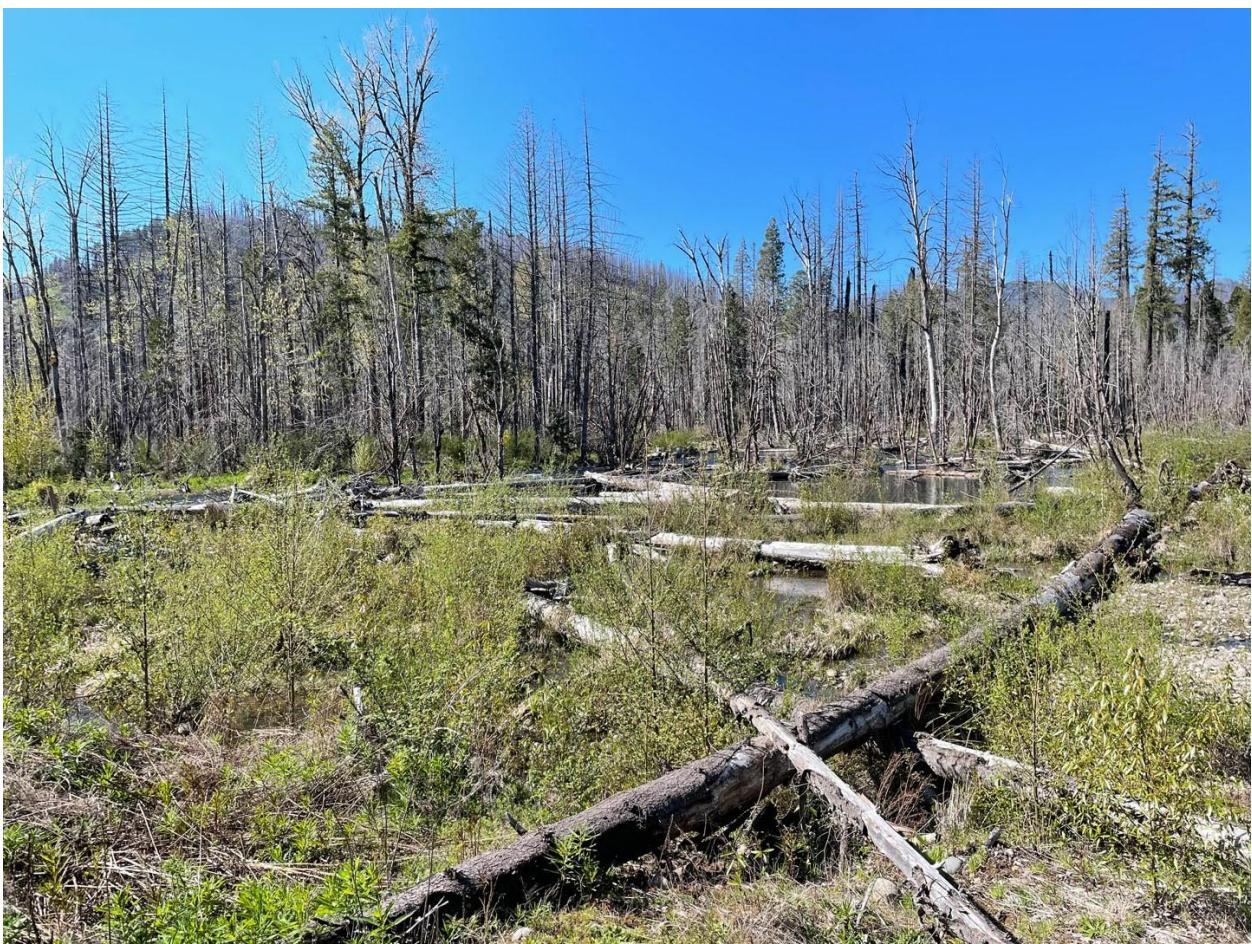
Figure 10. Willows are recolonizing the reconnected South Fork McKenzie River floodplain following the 2020 Holiday Farm wildfire.

At the end of Day 2, there was just time for a quick look at the large, multi-phase floodplain reconnection project that's on-going along the South Fork McKenzie River (https://www.fs.usda.gov/detail/willamette/landmanagement/resourcemanagement/?cid=fseprd58 4204#:~:text=Recognized%20for%20four%20consecutive%20years,Fork%20of%20the%20Mc Kenzie%20River. One last lesson we learned that afternoon was that reconnecting incised streams to their pre-disturbance floodplains has the added benefit of altering the impacts of wildfire moving through this fire-prone landscape. The behavior of the massive Holiday Farm Fire of 2020 changed from a uniform, high intensity burn to a "fire mosaic" when encountering the hydrologically-reconnected floodplain on the South Fork McKenzie River. This outcome is not only good for rivers, fish, biodiversity, and other natural conditions, it's also helping our communities become more resilient to the changing fire conditions now affecting Central Oregon.

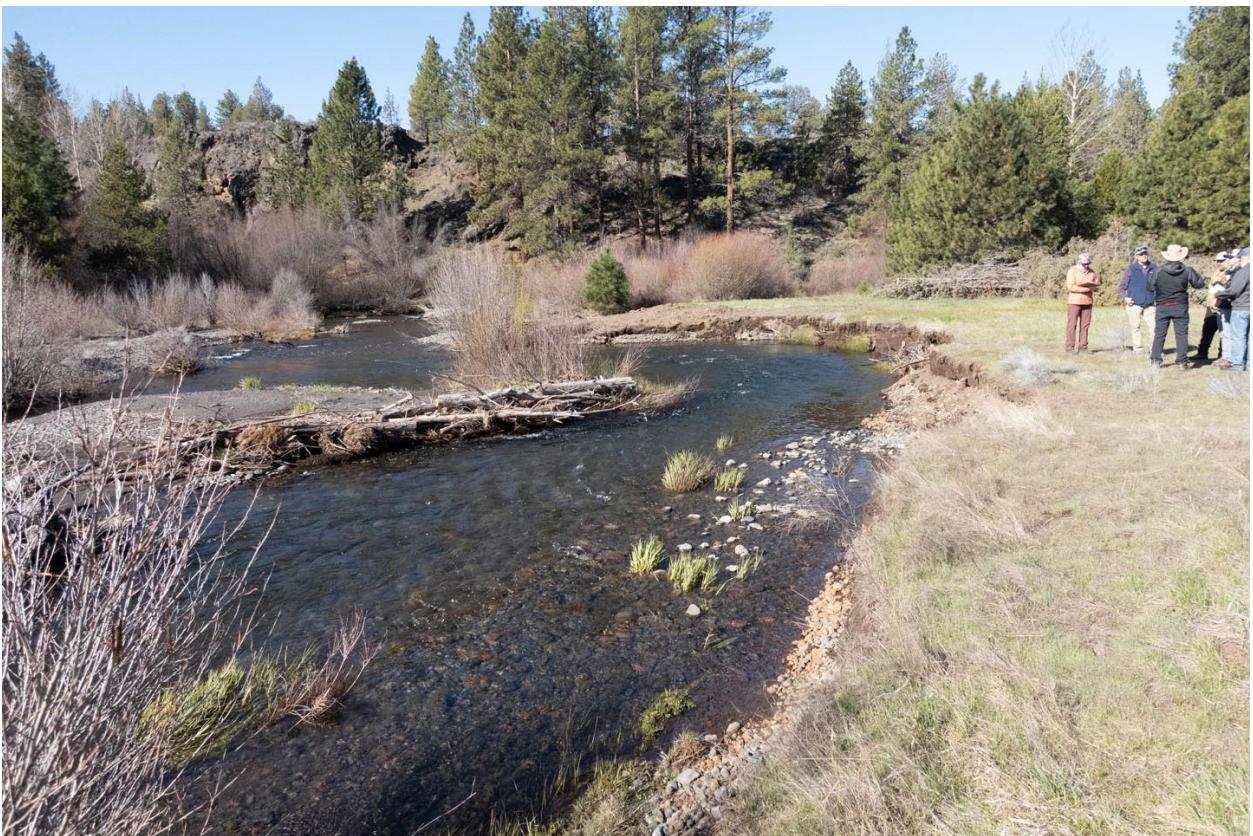
Figure 12. Post-assisted log structures (PALs) in the Willow Springs reach of Whychus Creek accelerate lateral channel migration to the right; lowering the floodplain by removing post-European settlement, legacy sediments. Note the willow growth on the left of creek, where legacy sediment removal and floodplain reconnection have already occurred.

At Whychus Creek we once again witnessed heroic restoration work being accomplished by very motivated and energetic teams of resource professionals. The joy and excitement they find in their work bubbled over as they showed off their amazing accomplishments. In the Willow Springs reach, simple post-assisted log structures (PALs) installed as part of Low Tech., Process Based Restoration (LTPBR - <u>https://lowtechpbr.restoration.usu.edu/</u>) was speeding up the Creek's natural meander processes in Stage 7 of the SEM, allowing the creek to sweep across its now-buried floodplain, removing post-development alluvium almost from valley wall to valley wall. With the legacy sediment removed in this low terrain floodplain, inundation will occur more frequently, the water table will be closer to the root zone, riparian vegetation (some planted, some natural) will flourish, and beavers will hopefully finish the job of assisting the valley floor to evolve to its Stage 8 configuration

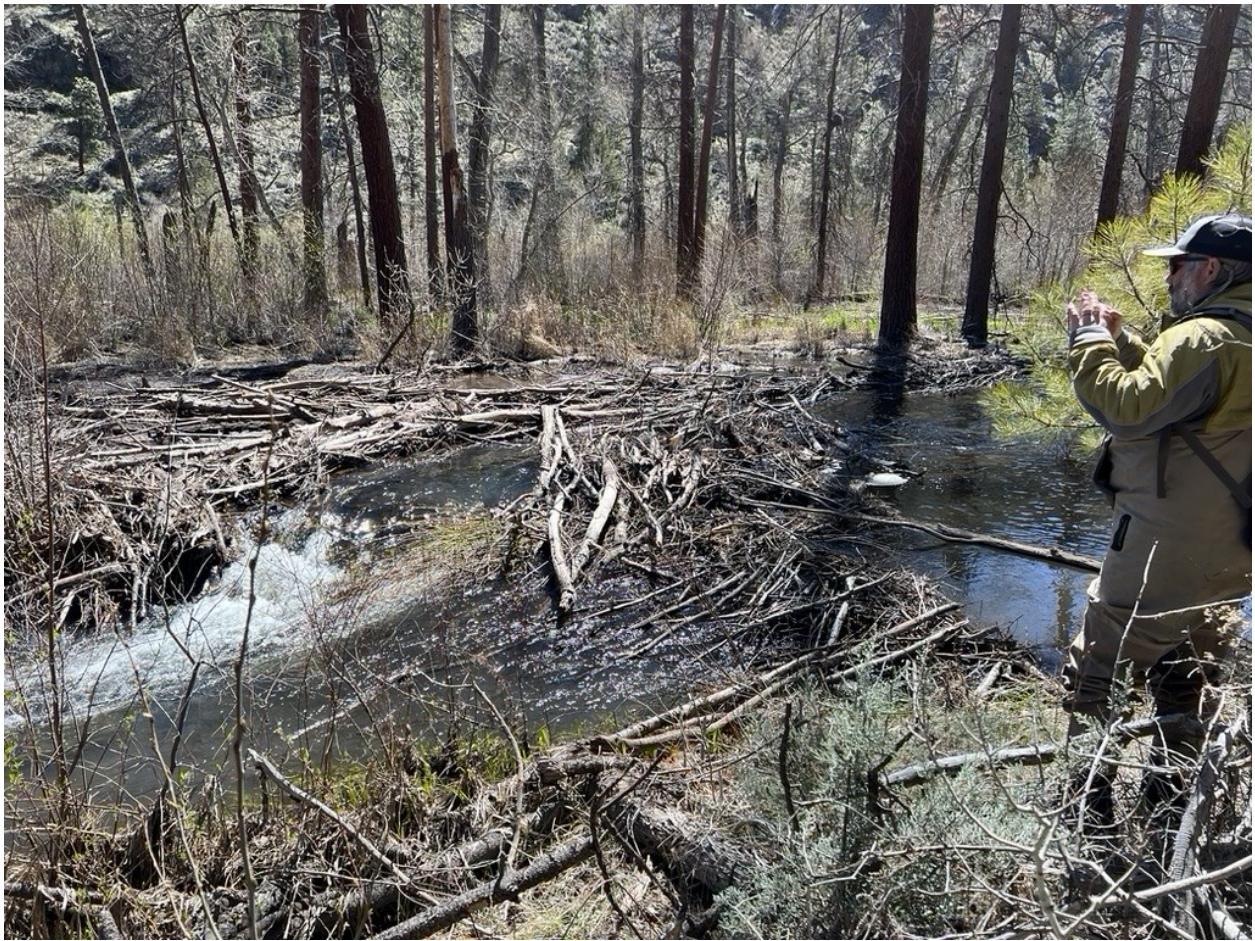
Figure 13. A new beaver dam in a reach of Whychus Creek that was restored to Stage 0 in 2016 using the 'valley floor reset' approach. Note the large amount of wood in the reconnected floodplain (some of which was placed and some of which has accumulated naturally) and that there is surface flow from valley wall to valley wall, even at base flow.

Other, more heavily incised Whychus Creek reaches we visited on Day 3 required a more intensive restoration approach than LTPBR, termed 'valley floor reset'. Levee removal, ditch filling, and removal of post-development deposition (using heavy machinery), followed by revegetation, wood placement, and strategically placed PALs were among the interventions needed to re-wet former floodplains in the Whychus Canyon Reserve (<u>https://www.deschuteslandtrust.org/visit/whychus-canyon-preserve/wc-creek-restoration</u>) and Rim Rock Ranch reaches (<u>https://www.deschuteslandtrust.org/visit/rimrock-ranch-restoration</u>), where channels were heavily incised. Early evidence suggests that these actions are achieving

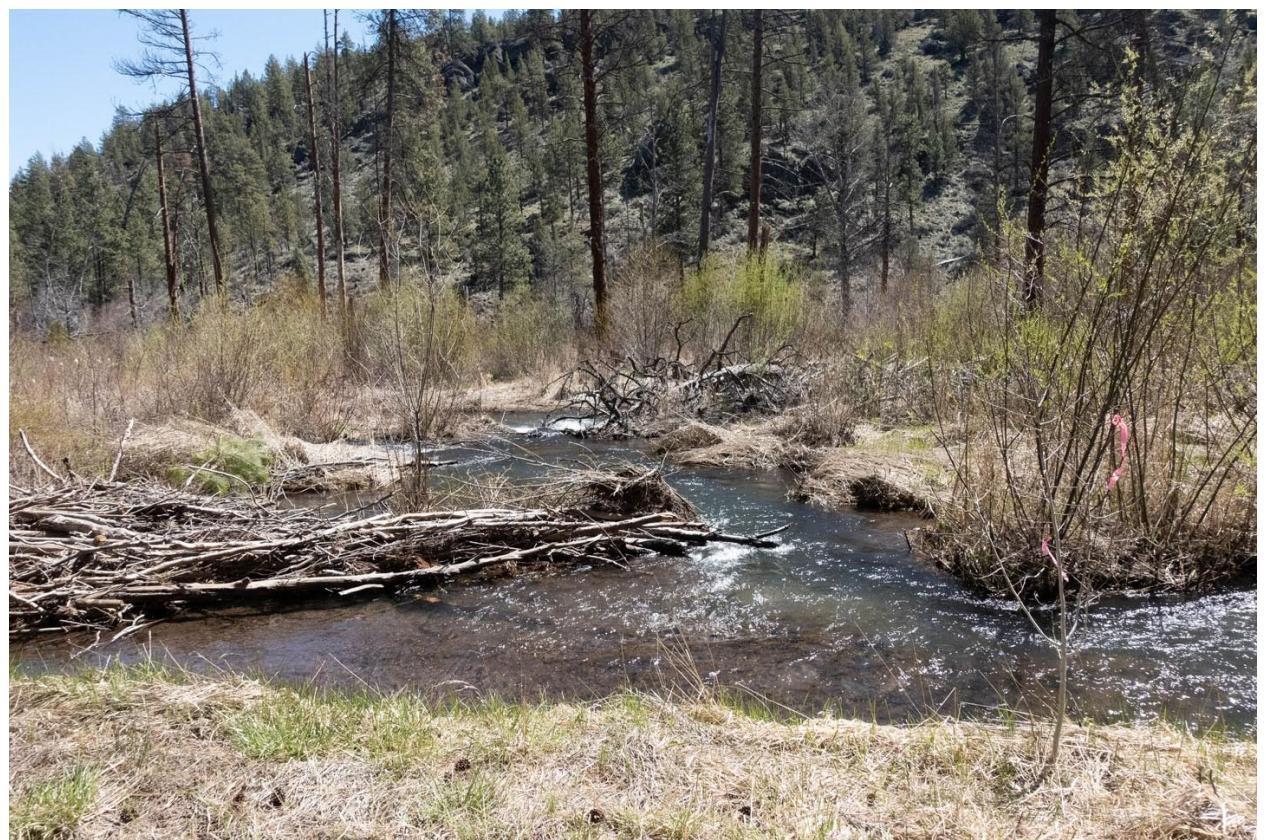
Figure 14. In the reach of Whychus Canyon Reserve restored in 2016, multiple, deep and narrow anabranches have formed within the re-wetted floodplain.

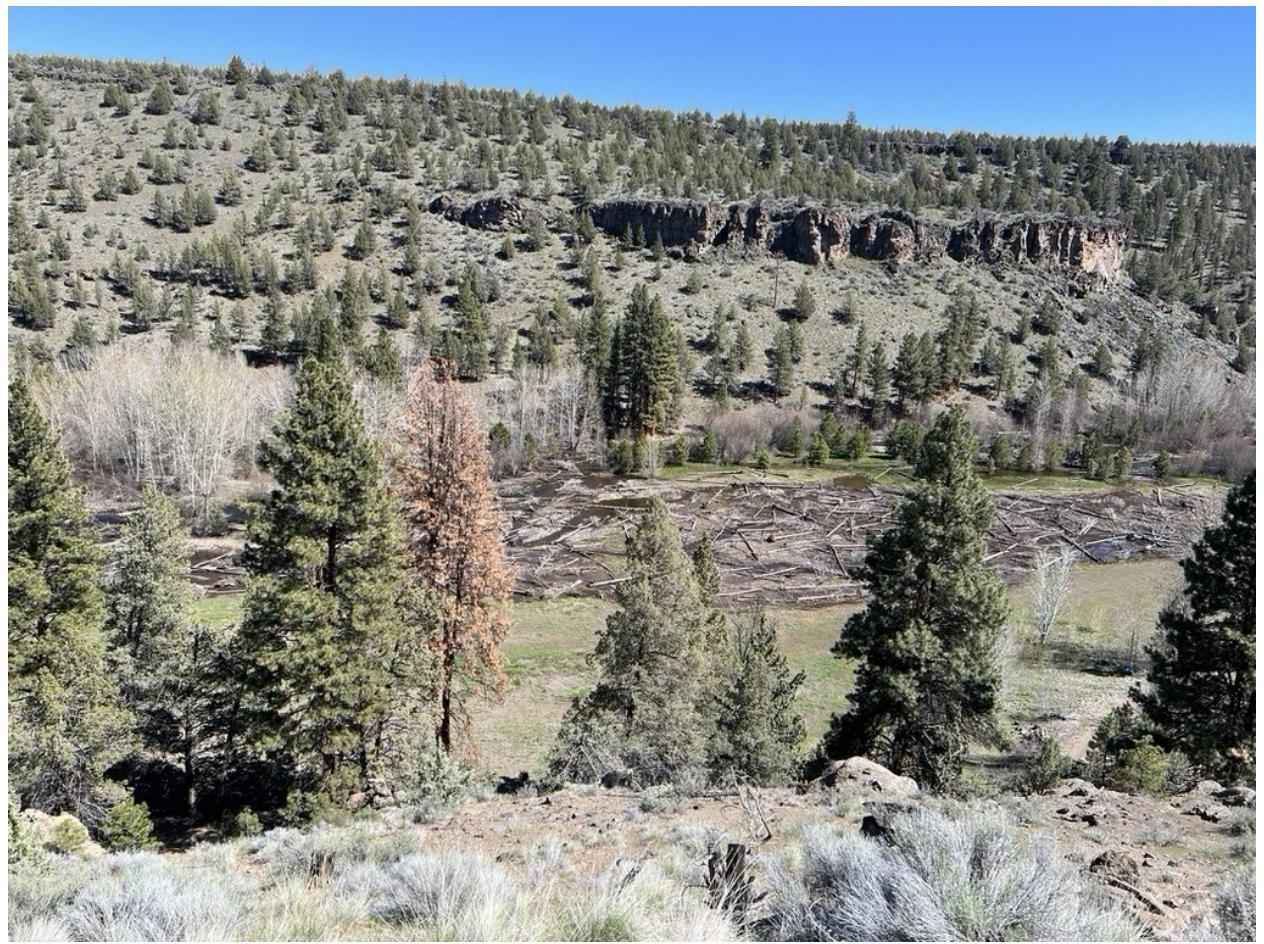
Figure 15. Rim Rock Ranch reach of Whychus Creek, which was restored using a 'valley floor reset' in 2023. As with other sites we visited, here post-European settlement alluvium was removed and used to fill the ditched channel. The historical floodplain is now once again fully connected to the stream at base flow. Post-project, adaptive management includes strategic placement of PALs to disperse flow through the large wood placed this site.

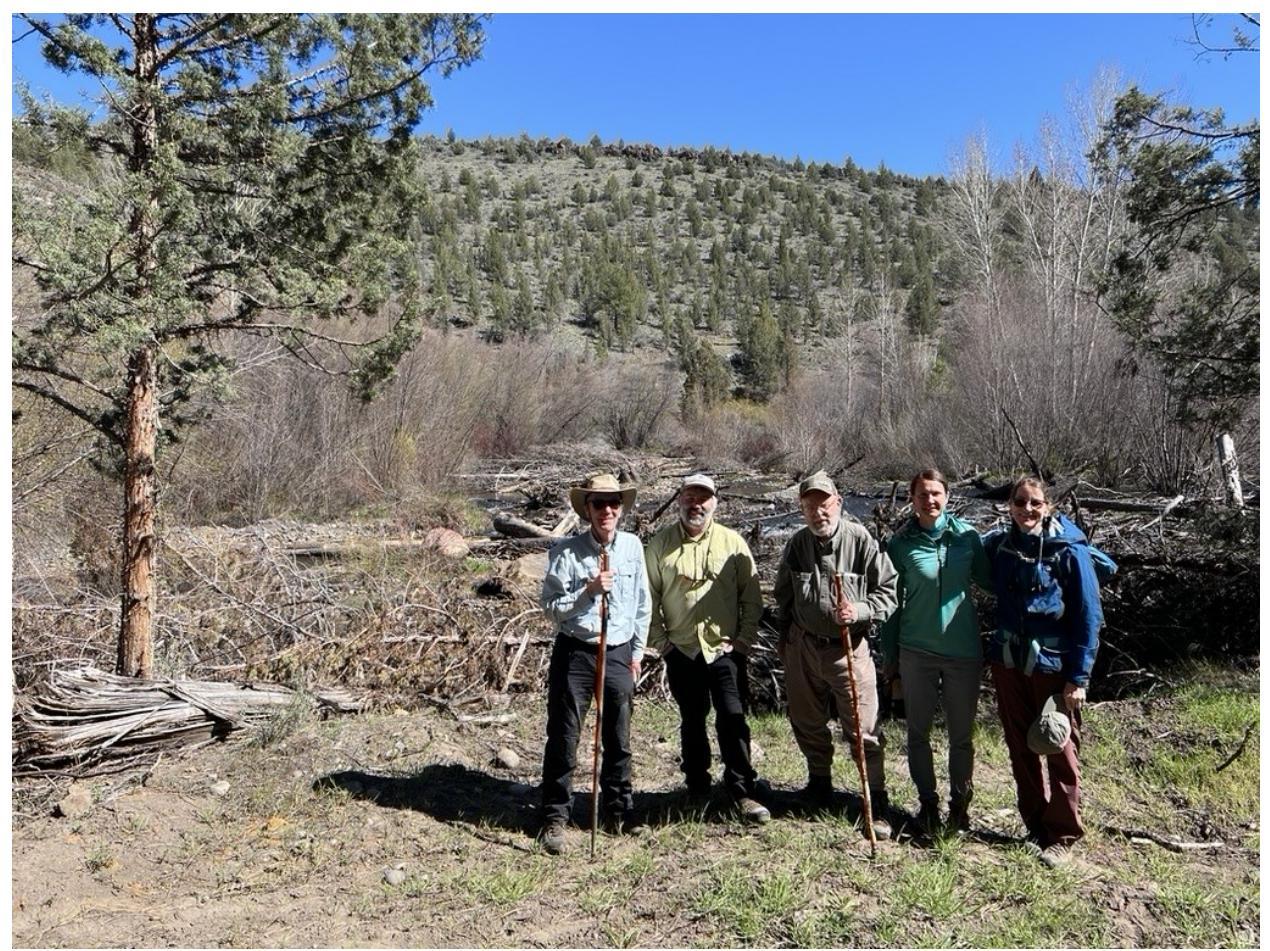
Figure 17. Partners and visitors in front of an extensive engineered log jam at the downstream termination of the Rim Rock Ranch project reach of Whychus Creek. This is the location of a natural geomorphic control, but nevertheless an extensive engineered log jam has been installed to ensure that no head cuts move into the restored reach from the unrestored, incised drainage system downstream. Left to right: Colin Thorne, Casey Schuder (Upper Deschutes Watershed Council), Ray White, Lauren Mork (UDWC), and Karen Allen (Aequinox Designing with Nature).
